Wildcat Creek in Howard County
Stream Stability Assessment
Howard County, IN | November 2017

Howard County Stormwater District

Christopher B. Burke Engineering, LLC
115 West Washington Street, Suite 1368 South
Indianapolis, Indiana 46204

CBBEL Project No. 15-0132.00000

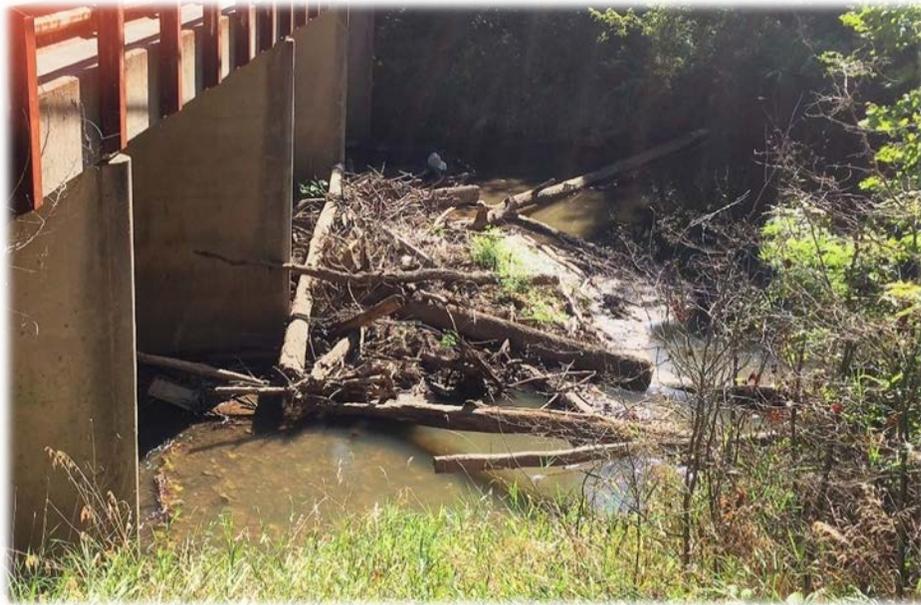
Figure 5: Large Wood at County Road E 100 N

2. **Large Wood (LW):** LW was observed along Wildcat Creek primarily upstream of the Kokomo reservoir, and downstream of the quarry west of Kokomo. The debris includes fallen trees in the creek and along the channel banks. Some minor logjams have formed in a few locations along the creek, some of which appear to direct flow toward the channel banks.

The data collected show that only 35% of the bridges assessed on Wildcat Creek had Large Wood (LW) associated with them, and the largest accumulation of LW was found on Mud Creek, a headwater tributary. The LW observed was most common in and downstream from disturbance areas. These data suggest that wood management in the Wildcat Creek corridor is not a chronic problem, but an occasional acute problem because of very high stream flow, or a severe storm, like the August 2016 tornadoes.

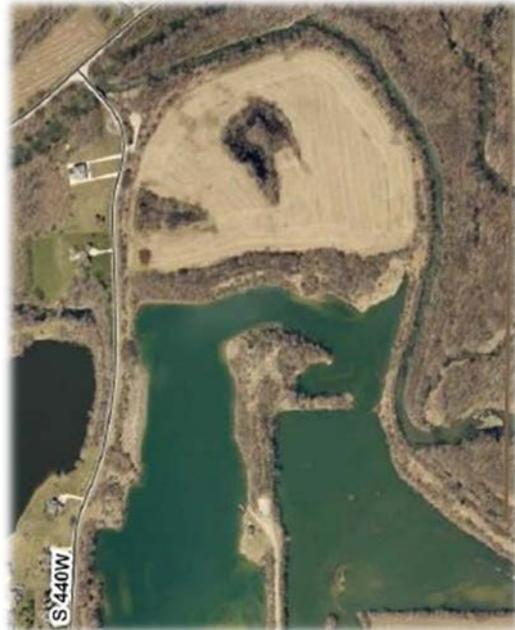
Figure 6: Location of 2003 Berm Failure

3. Rock Quarries: Over the years, rock quarries have been mined in several locations along Wildcat Creek and there is currently one active quarry located west of Kokomo. Some abandoned quarry areas have been developed into residential neighborhoods. Berms originally built to isolate the gravel pits from the creek have been breached which allowed Wildcat Creek flows to pass through the pits. One such location is upstream of County Road E440W which breached in 2003, shown in **Figure 6**. Other locations along the berms appear to be in imminent danger of failure if not properly assessed and mitigated.

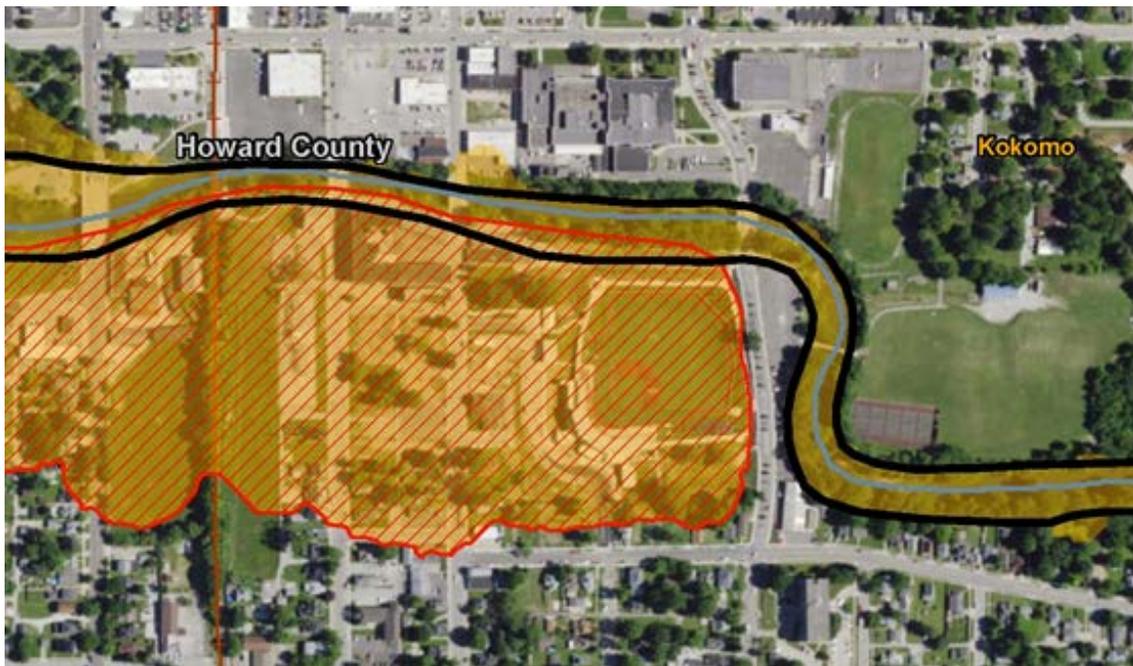
Figure 15: Example of Filled Floodplain Areas

the FIS flood profiles through Kokomo are provided in **Exhibit 3**. As can be seen from the Exhibit, flood profiles jump up considerably through the City's urbanized reach in response to loss of cross sectional area due to floodplain fill, restrictive crossings, and low-head dams. The floodway map was reviewed to identify areas where the floodway is obviously narrow. These indicate locations where most of the flow must pass through a narrow passageway which could be a restrictive bridge or culvert, or areas where the overbank floodplain has been blocked or filled. Floodplain storage was evaluated by comparing the regulatory floodway and floodplain. Areas with little or no adjacent floodplain, or that show development in the floodplain indicate compromised floodplain storage and connectivity. As an example, **Figure 15** shows a portion of Wildcat Creek in downtown Kokomo indicating filled and developed floodplain areas.

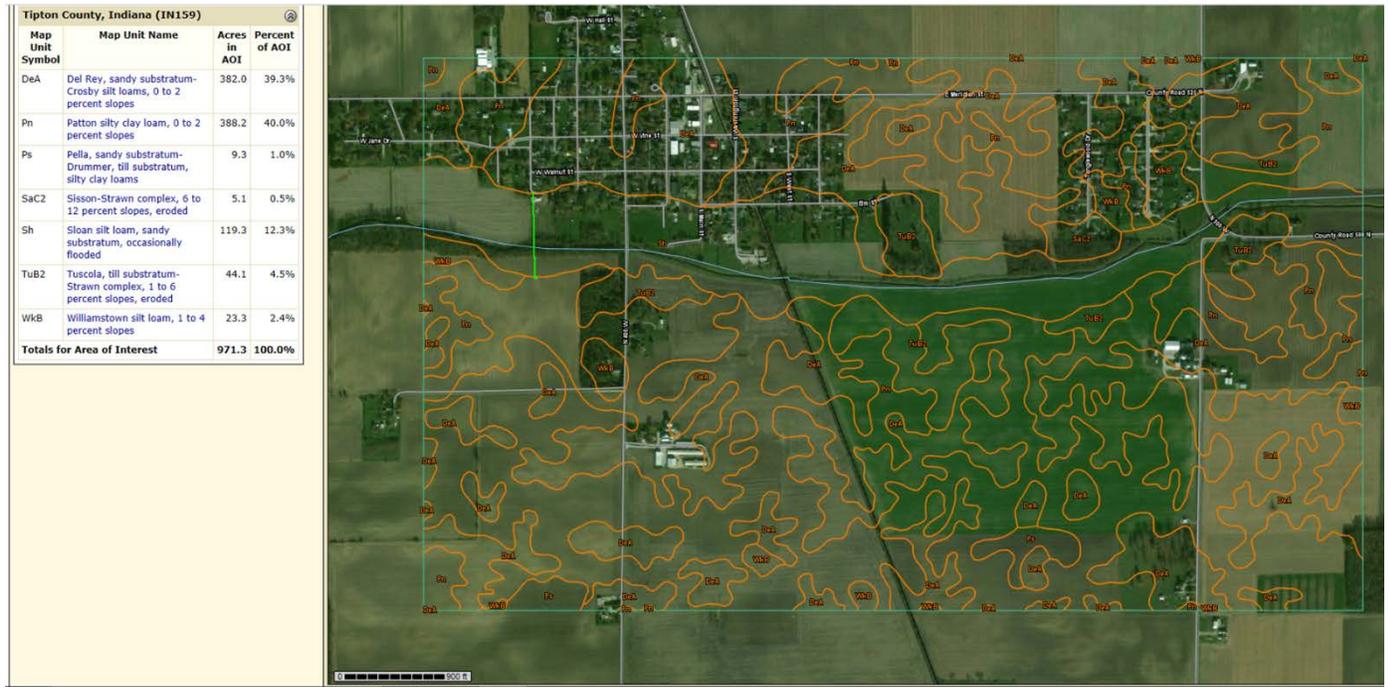
Figure 4 shows that alluvial deposits associated with Wildcat Creek become significant enough to be mapped at a state-wide scale near Kokomo. Alluvial soils and therefore a geomorphic floodplain extend on a smaller scale past Sharpsville in Tipton County (Figure 5), and just past the confluence of Wildcat Creek and Grassy Creek. The geomorphic floodplains also correspond with a change in geology. The floodplains in Wildcat Creek occur in areas underlain by outwash deposits.

Figure 5: Detail from Web Soil Survey for a portion of Tipton County near Sharpsville, IN. The bright green line indicates the average width (600-feet) of the Shoals silt-loam alluvium (Sh). That soil is developed on floodplains.

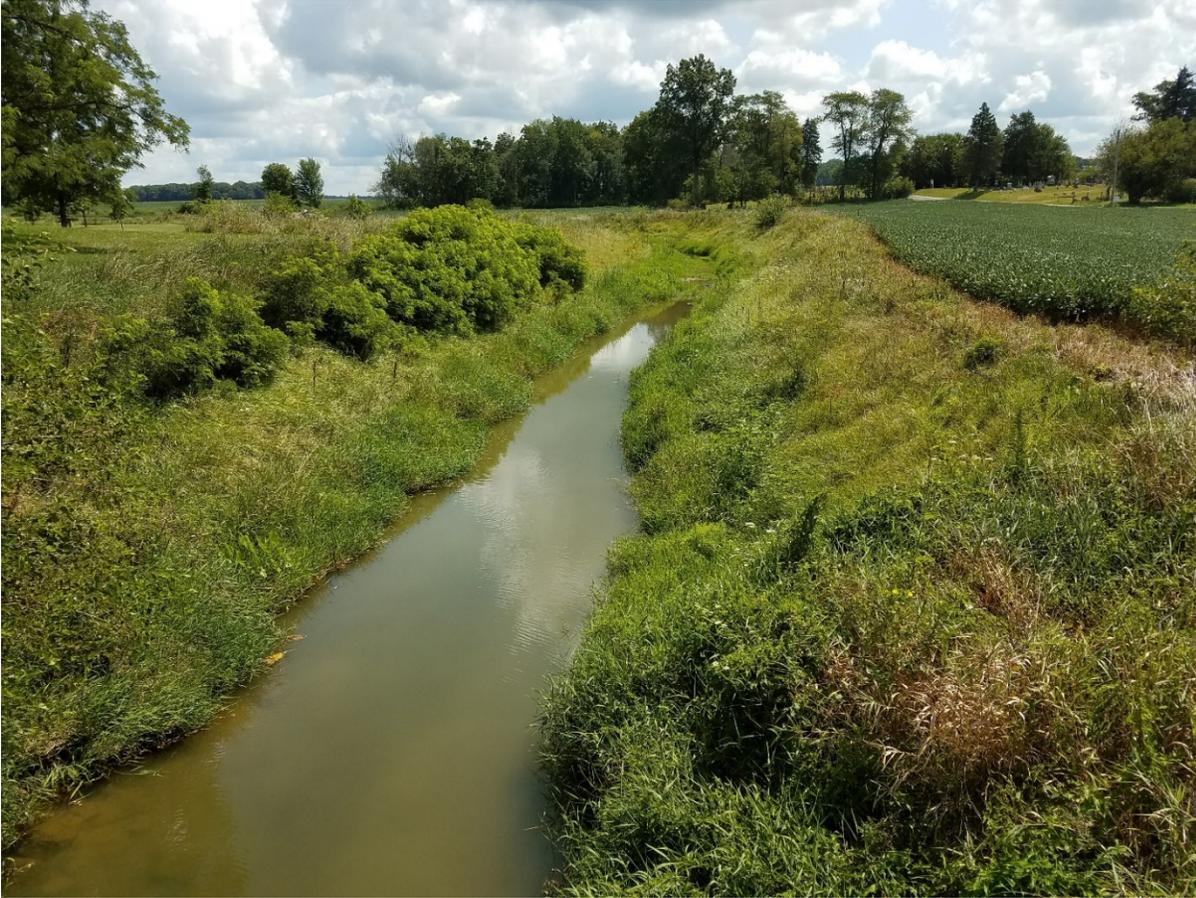
Figure 7: Agriculturally-modified section of Mud Creek upstream from Sharpsville, Tipton County, Indiana. Stream channel evolution stage II (Figure 10)

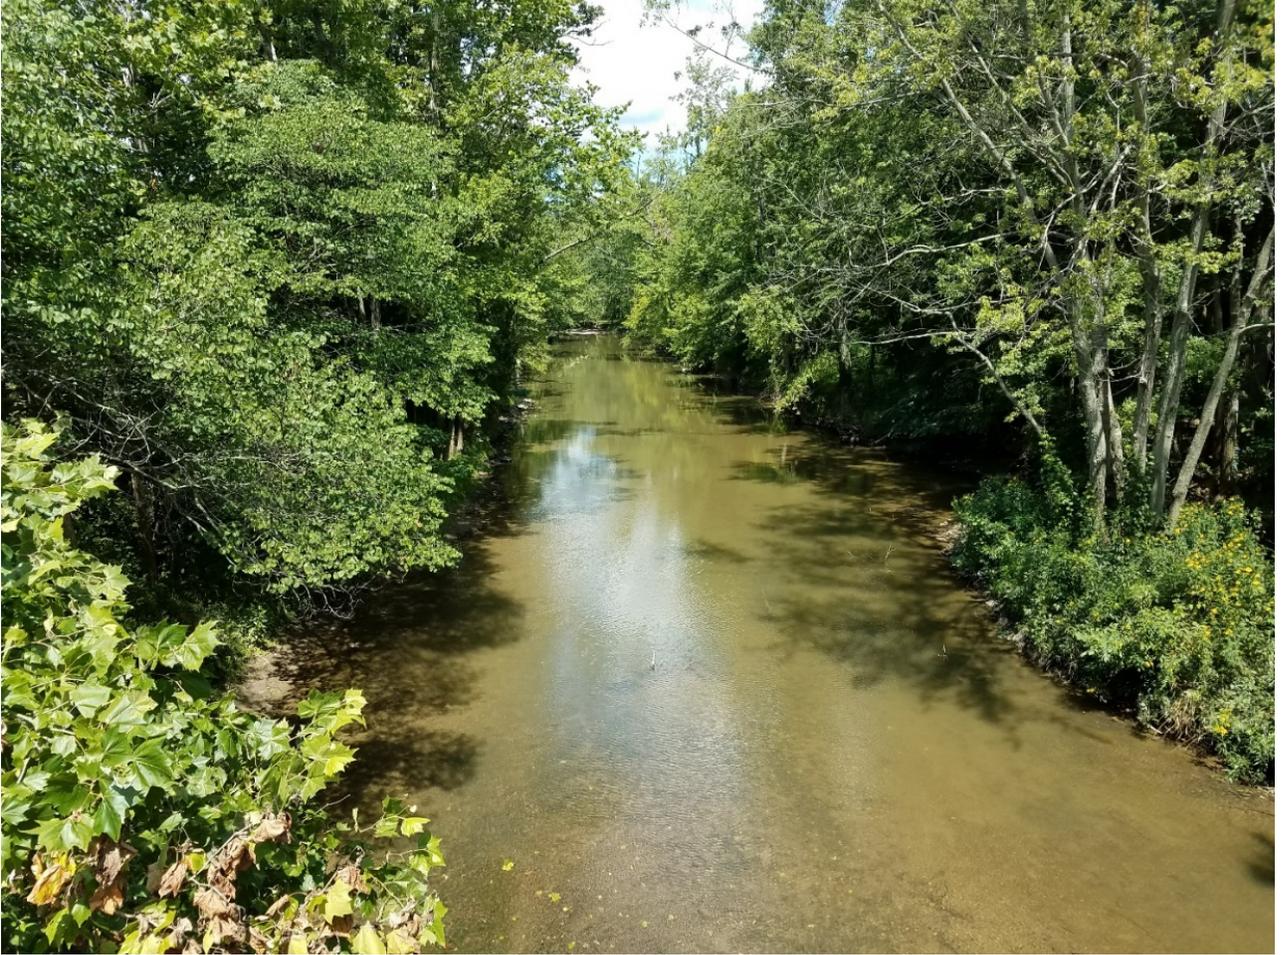
Figure 8: Mud Creek near confluence with Middle Fork Wildcat Creek, upstream of Jerome. Note change in riparian vegetation and stream type.

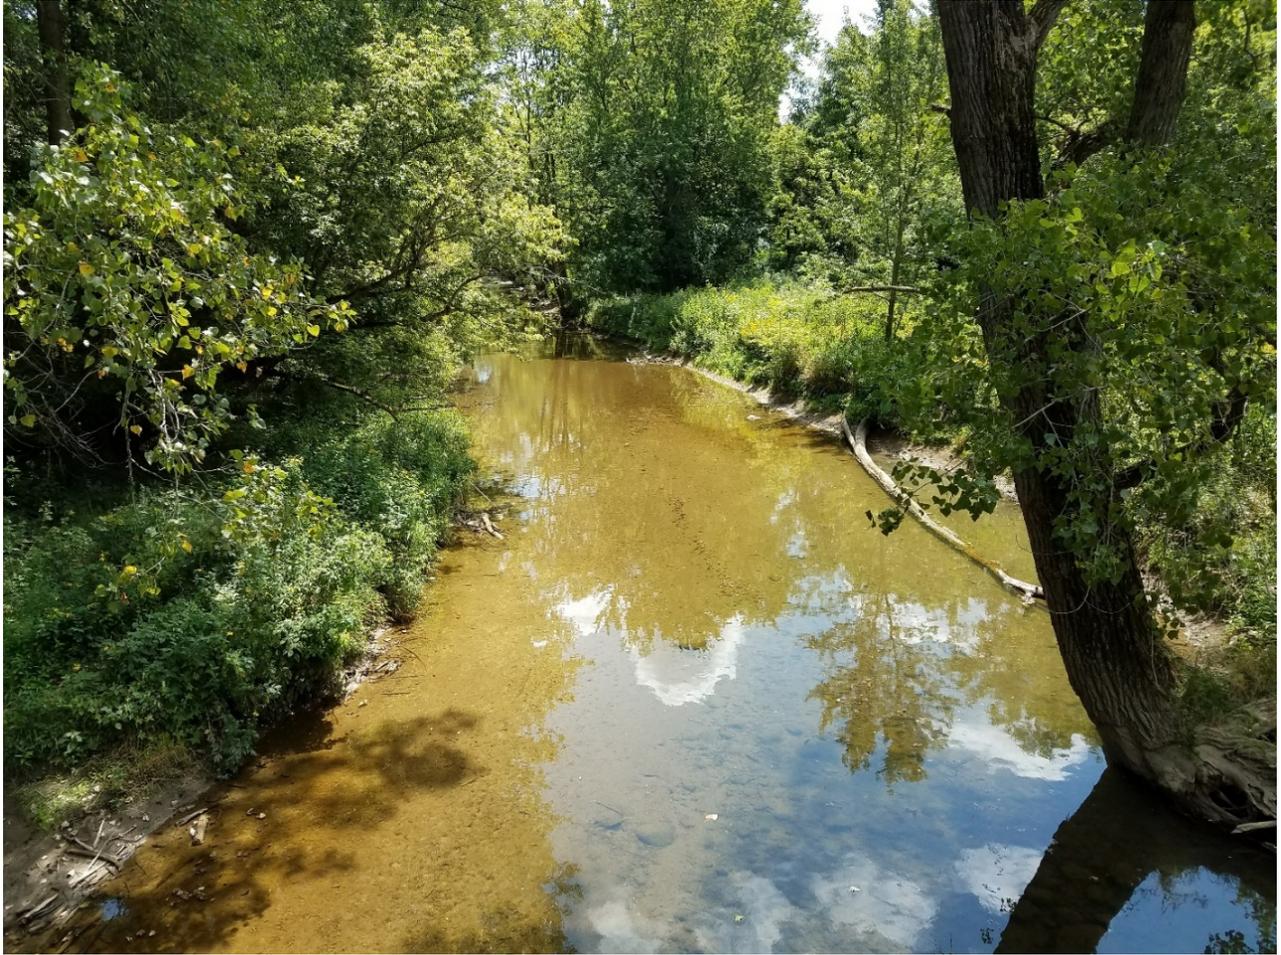
Figure 9: Middle Fork Wildcat Creek at confluence with Mud Creek, upstream of Jerome. Note riparian vegetation and stream type.

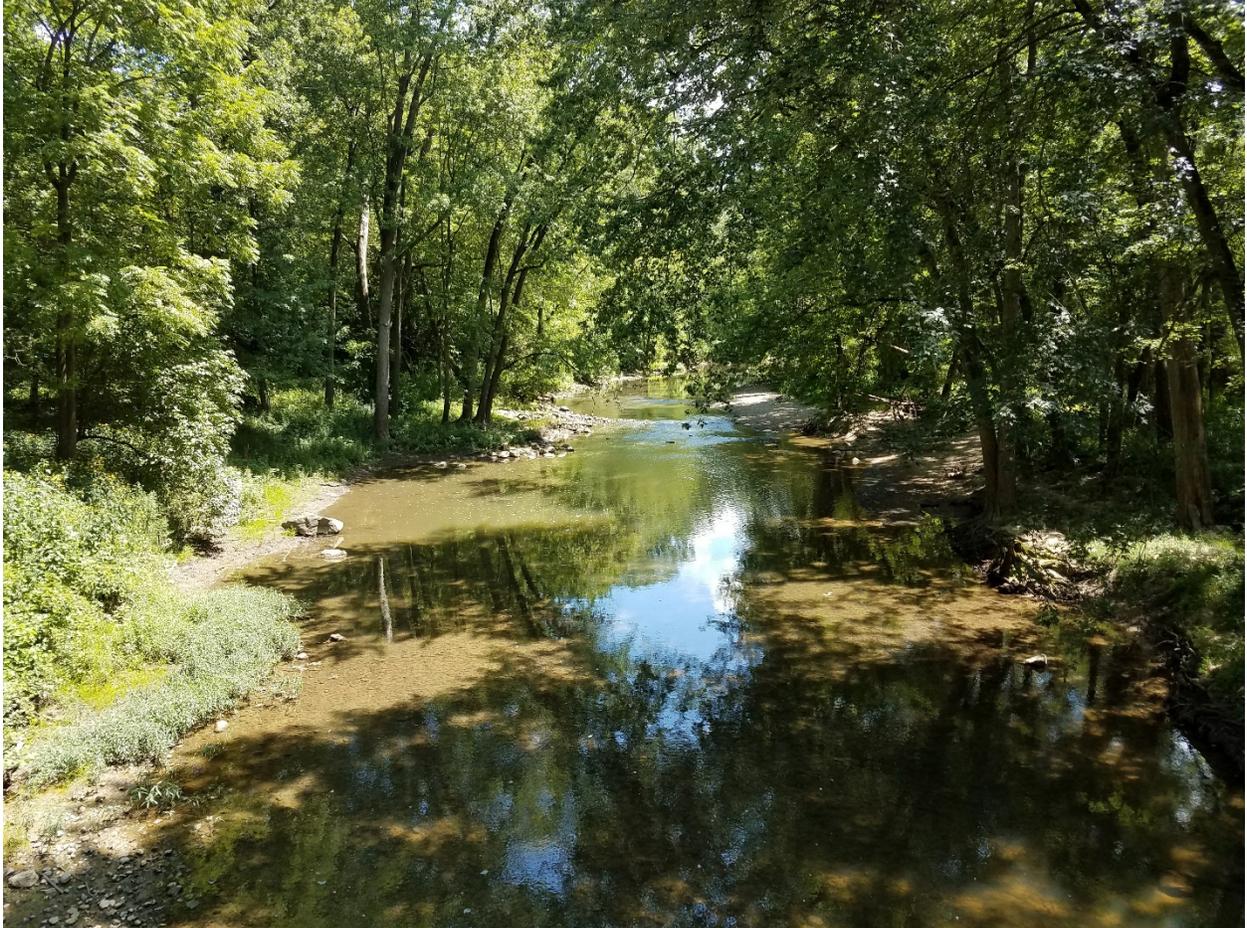
Figure 11: Wildcat Creek at Jerome Bridge, looking upstream. Note the well-connected riparian forest.

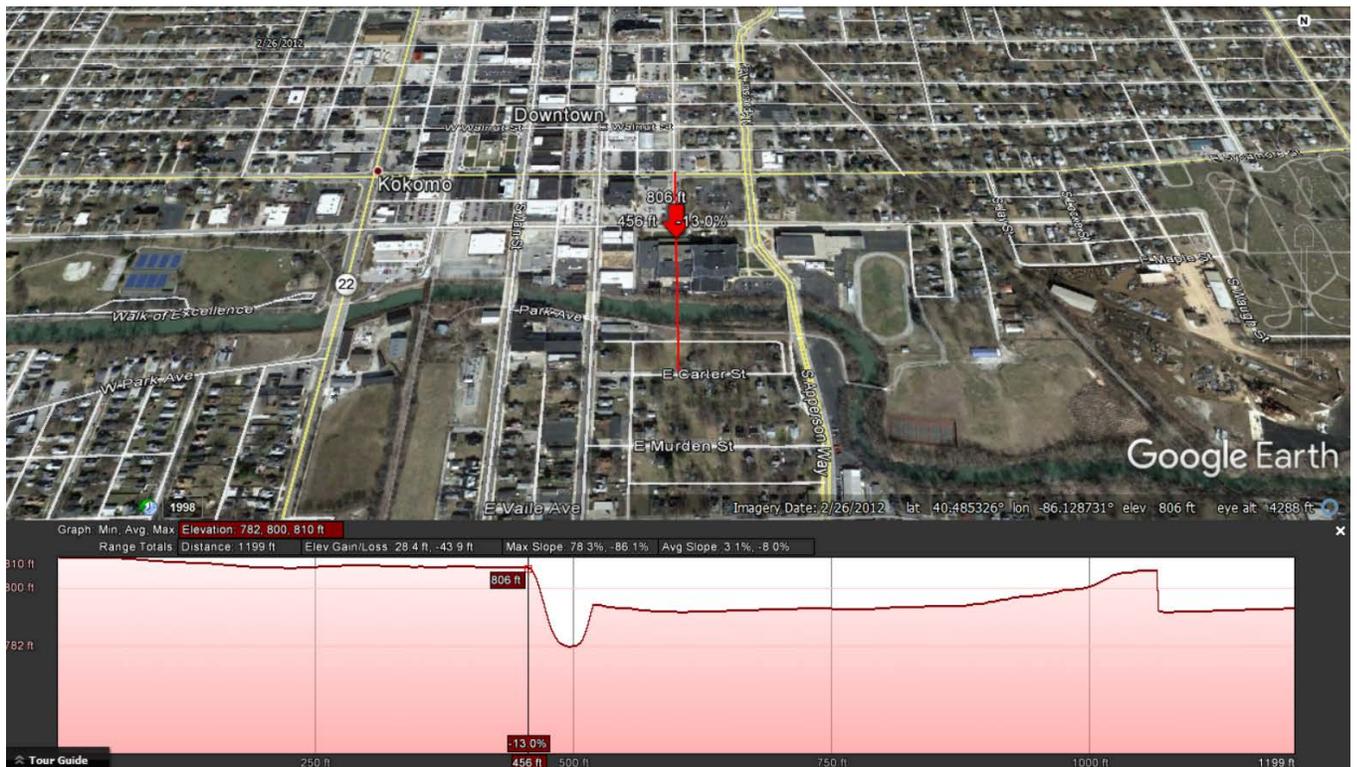
Figure 19: Channel cross-section near Apperson Way (Google Earth)

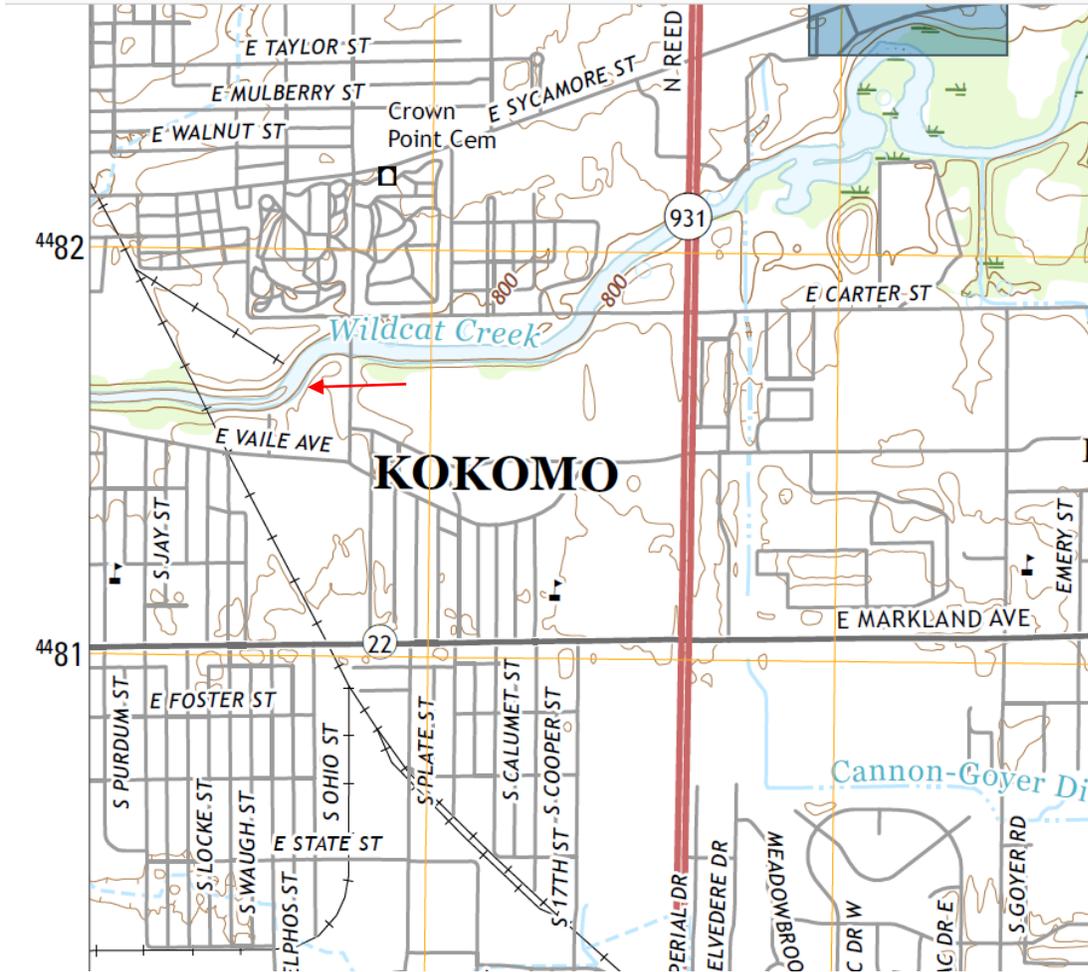
Figure 20: Detail from USGS 1:24,000 Series Topographic Map, Kokomo East, 2016. The contour interval is 10-feet. Note the new contour line downstream from US 931 (red arrow).

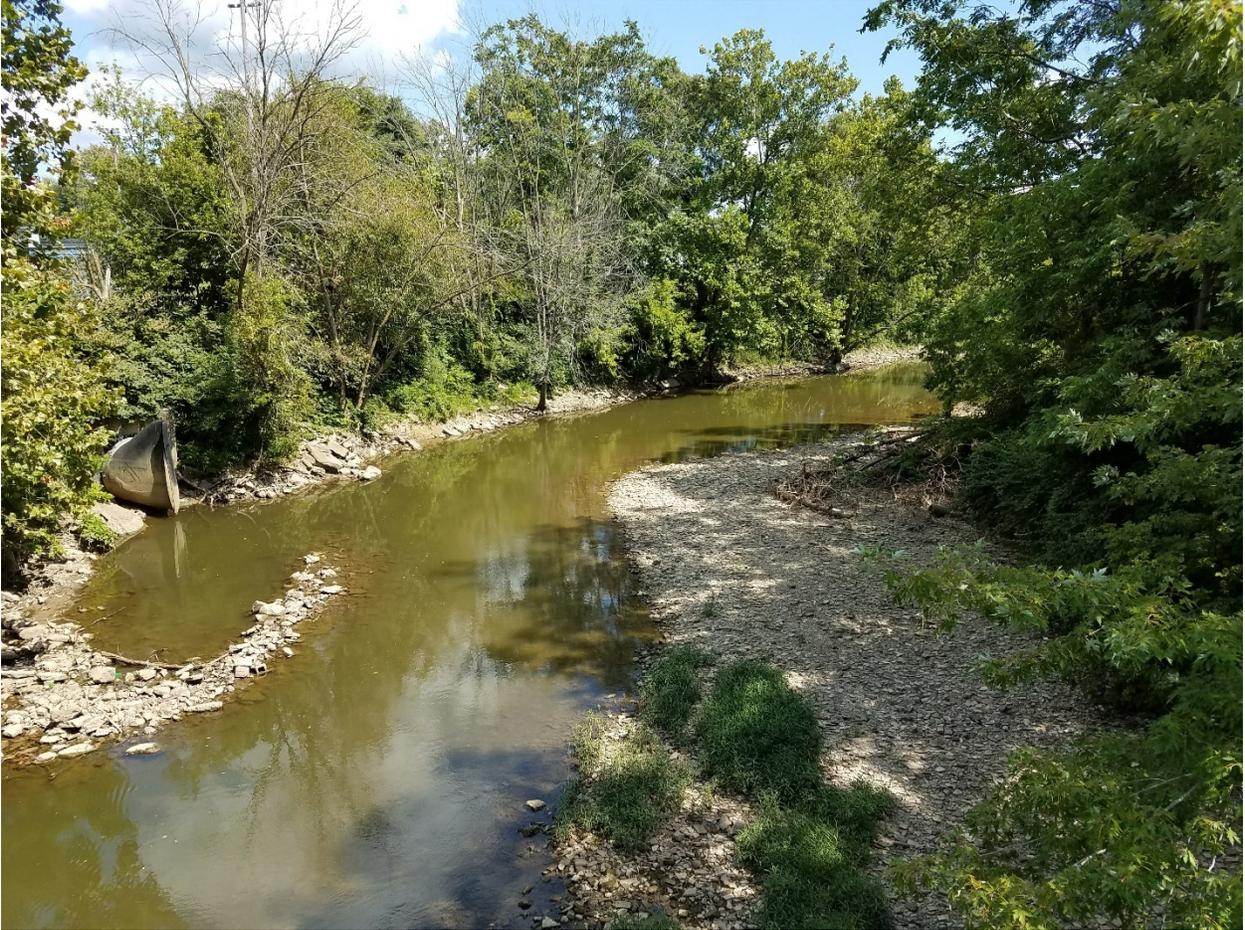
Figure 21: Wildcat Creek at Apperson Way, looking upstream. Note CSO outfall on right bank, and developing point bar.

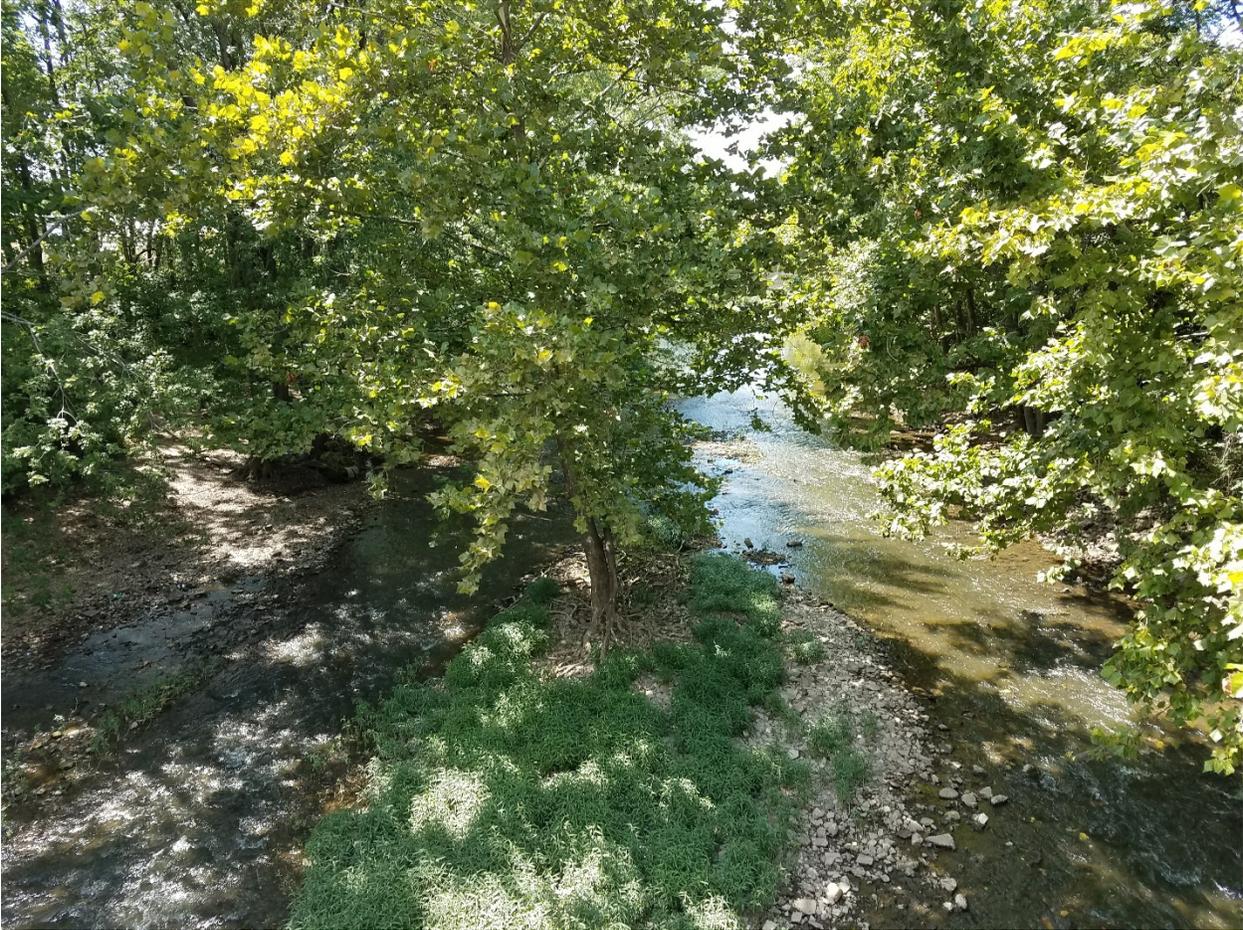
Figure 22: Wildcat Creek at Apperson Way, looking downstream. Note in-channel bar with mature tree.

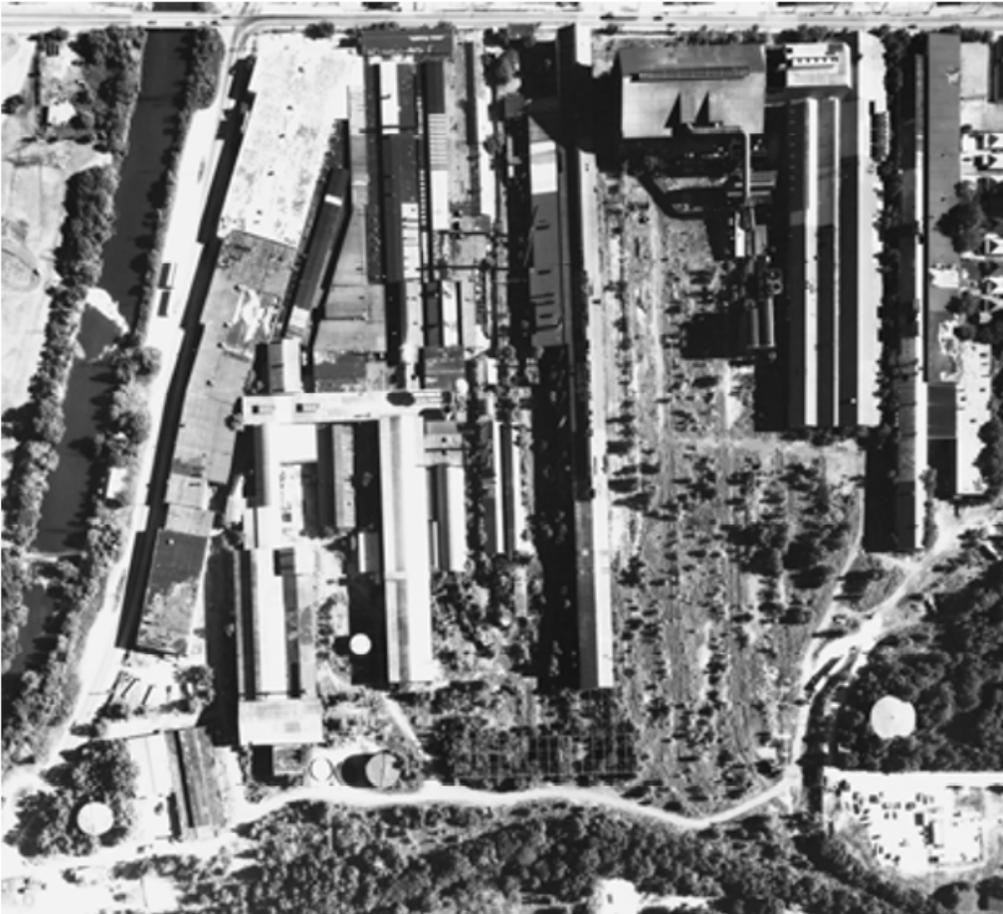
Figure 23: Continental Steel Facility, Kokomo, IN, Pre-demolition photo, Main Plant Area, 1998.

Wildcat Creek is visible on the left side of the image.

Downstream from the Apperson site, and on the west side of the city, there is a 2.0-mile section of Wildcat Creek and Kokomo Creek that were vacuum dredged during the remediation of the Continental Steel facility (USEPA, 2008; Figures 23,24,25,26). EPA documents (USEPA, 2010) indicate that from 0.4 to 2.5-feet of contaminated sediment were removed from the stream bed. Extensive remediation of the banks was done as well, which has given the reach a straightened appearance.

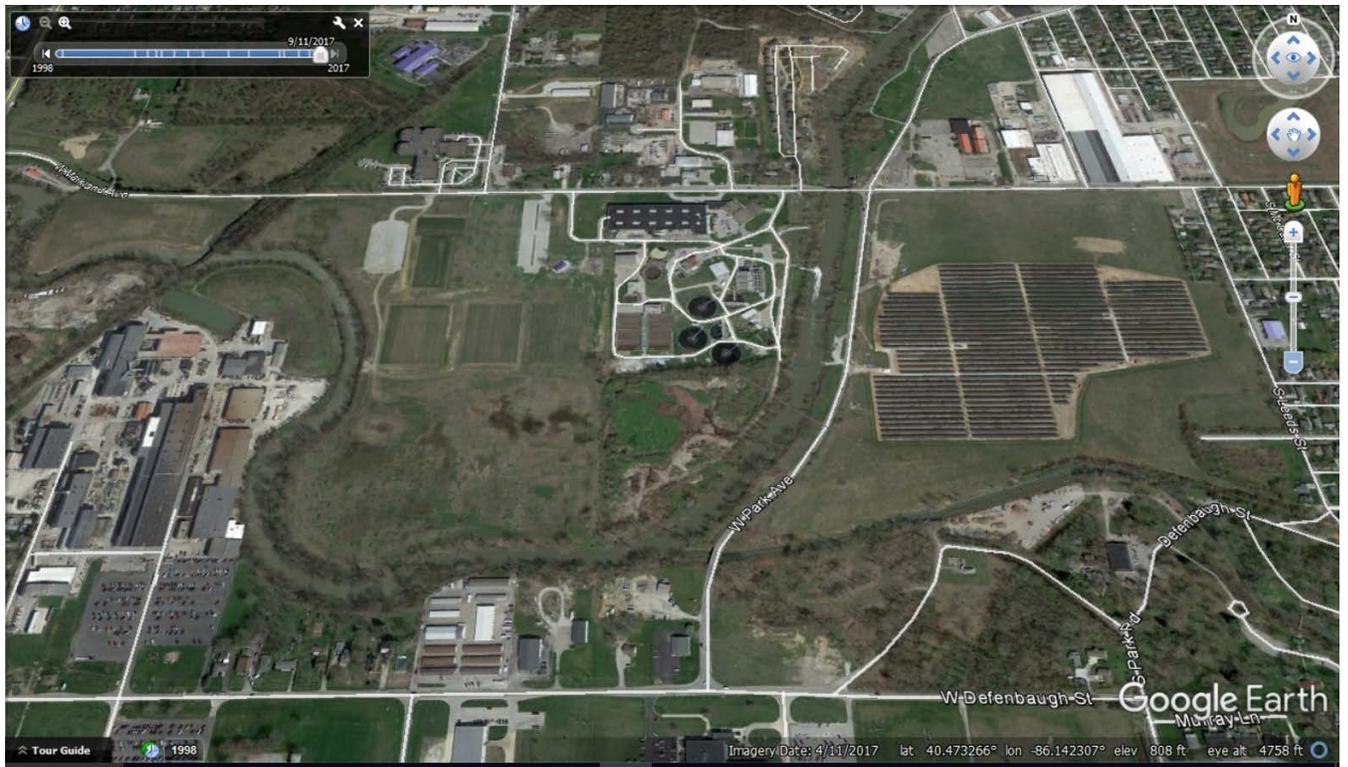
Figure 24: Site of the former Continental Steel Facility, Kokomo, IN. 2017. Note Kokomo Creek in the foreground of the lower right side of the image. Flow direction in Wildcat Creek is from the top of the image.

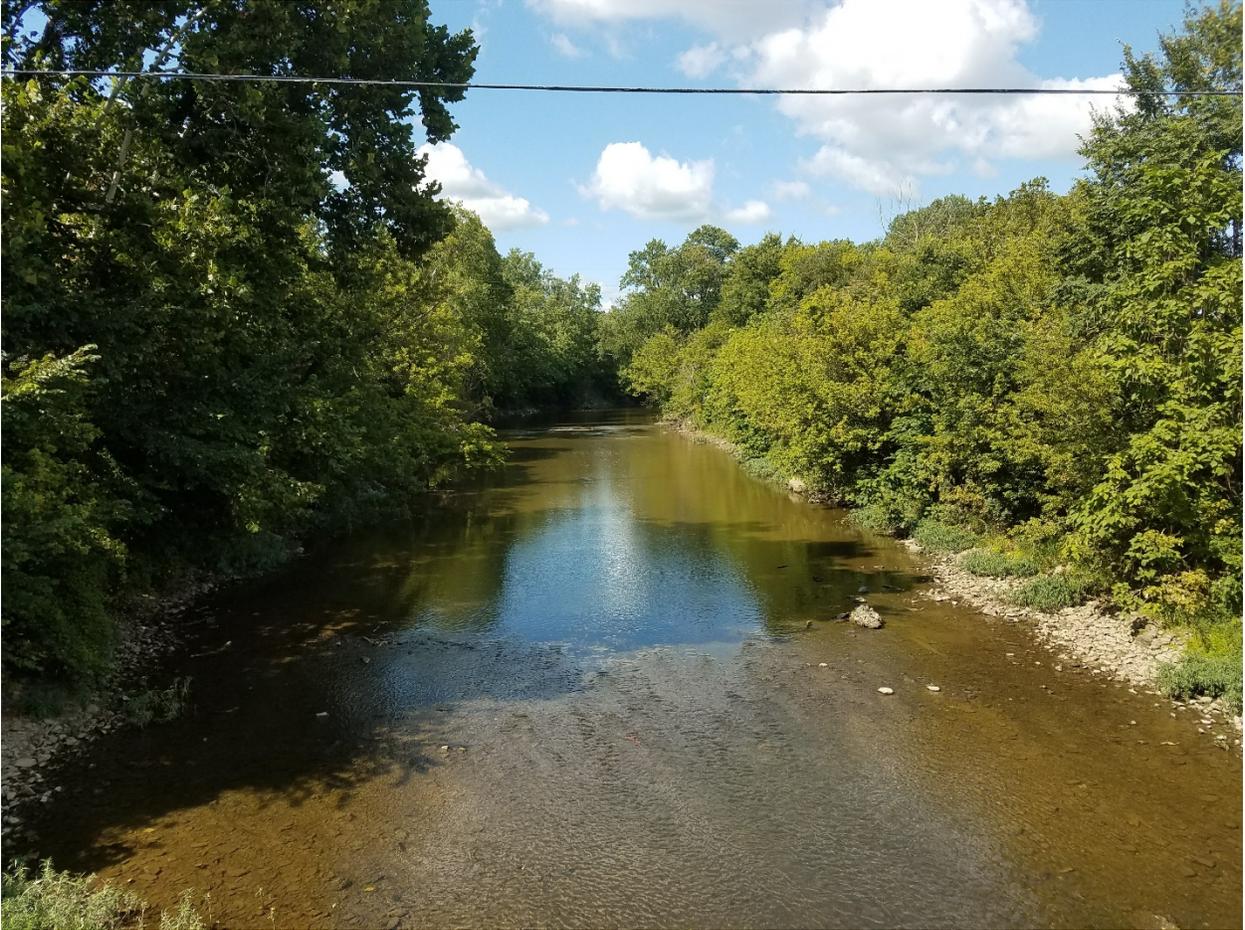
Figure 25: Wildcat Creek at Markland Avenue, looking upstream. Note straightened form, uniform width, and lack of bed features.

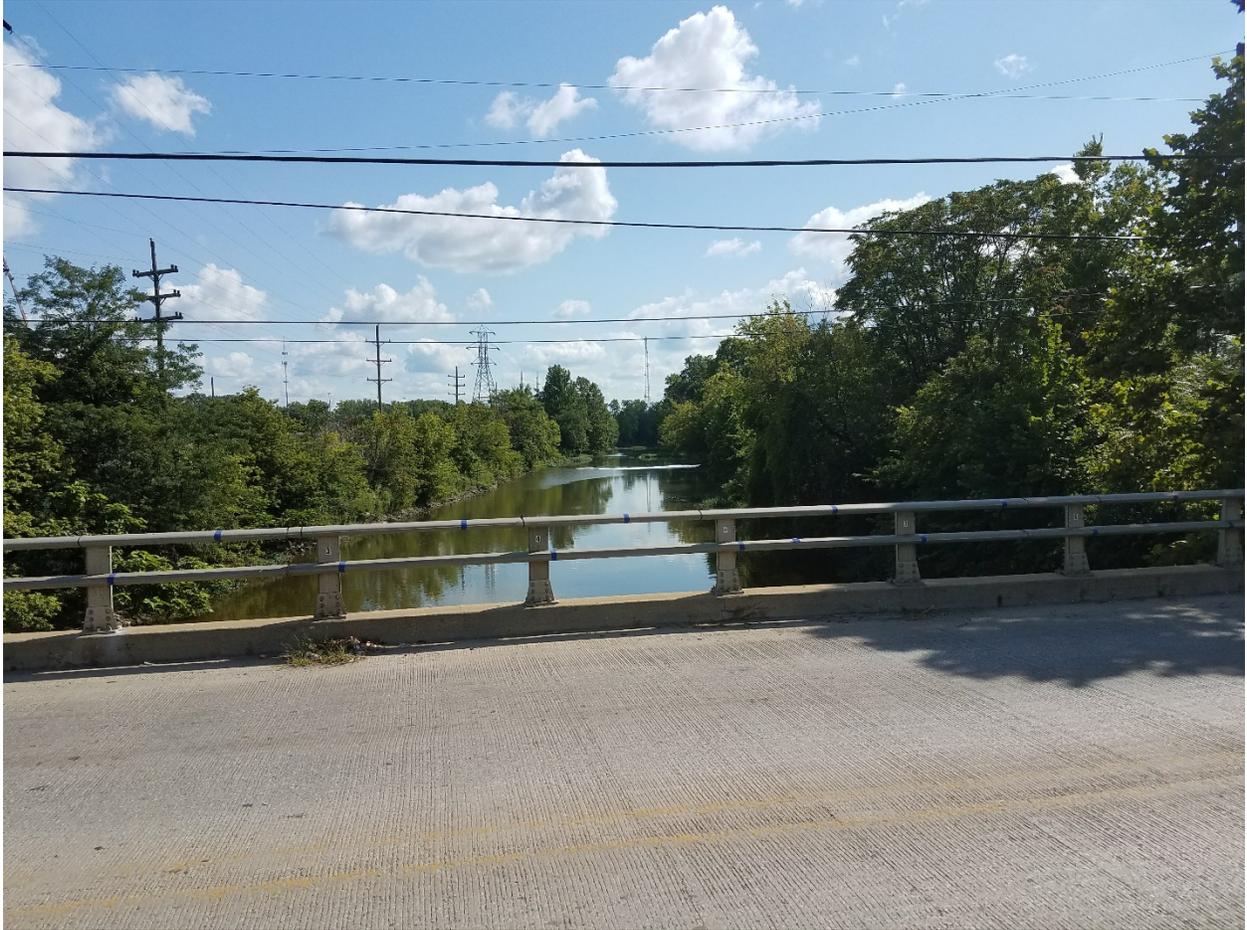
Figure 26: Wildcat Creek at Markland Avenue, looking downstream at the reach that was vacuum-dredged.

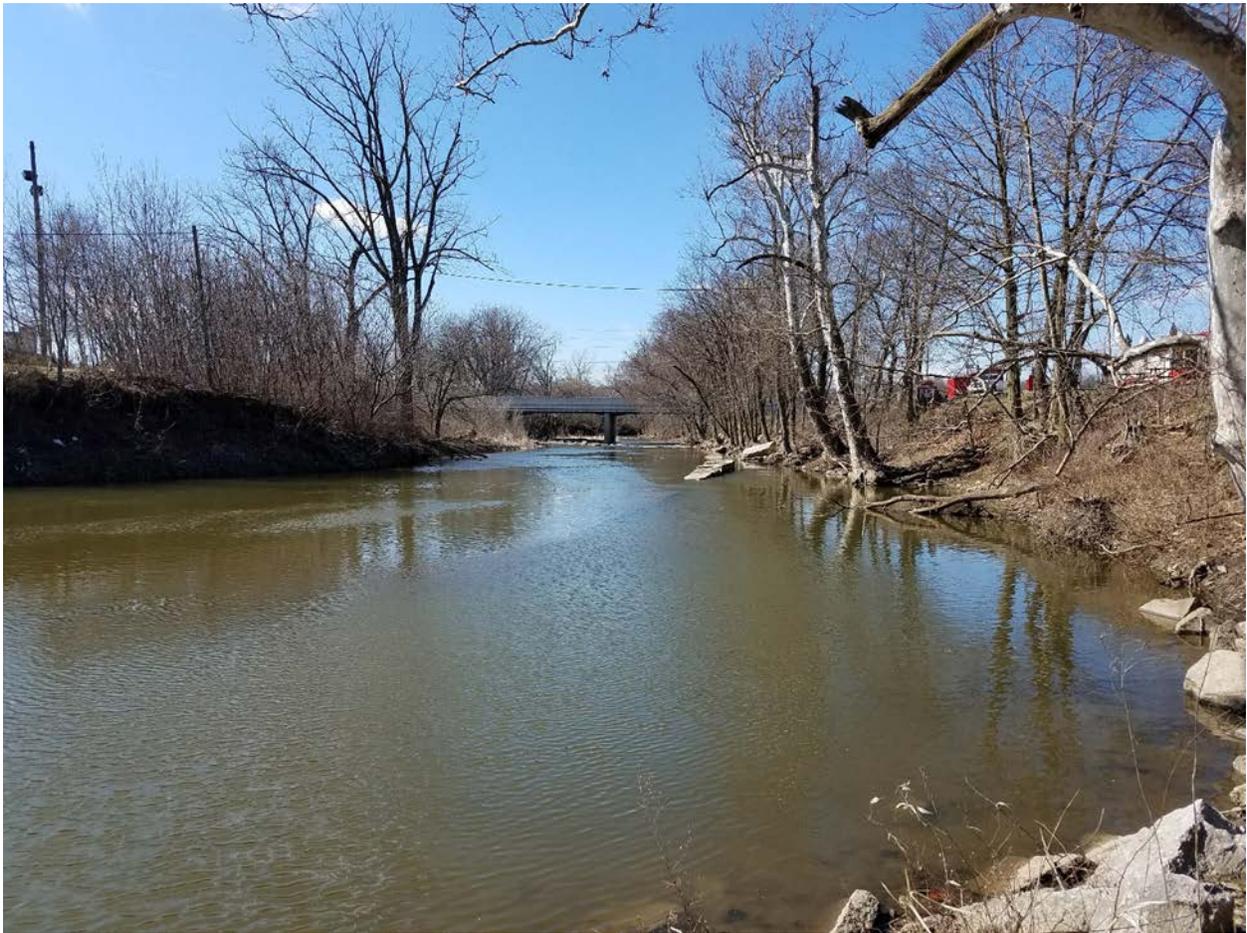
Figure 27: Wildcat Creek upstream of Dixon Road. Note debris falling out of left bank.

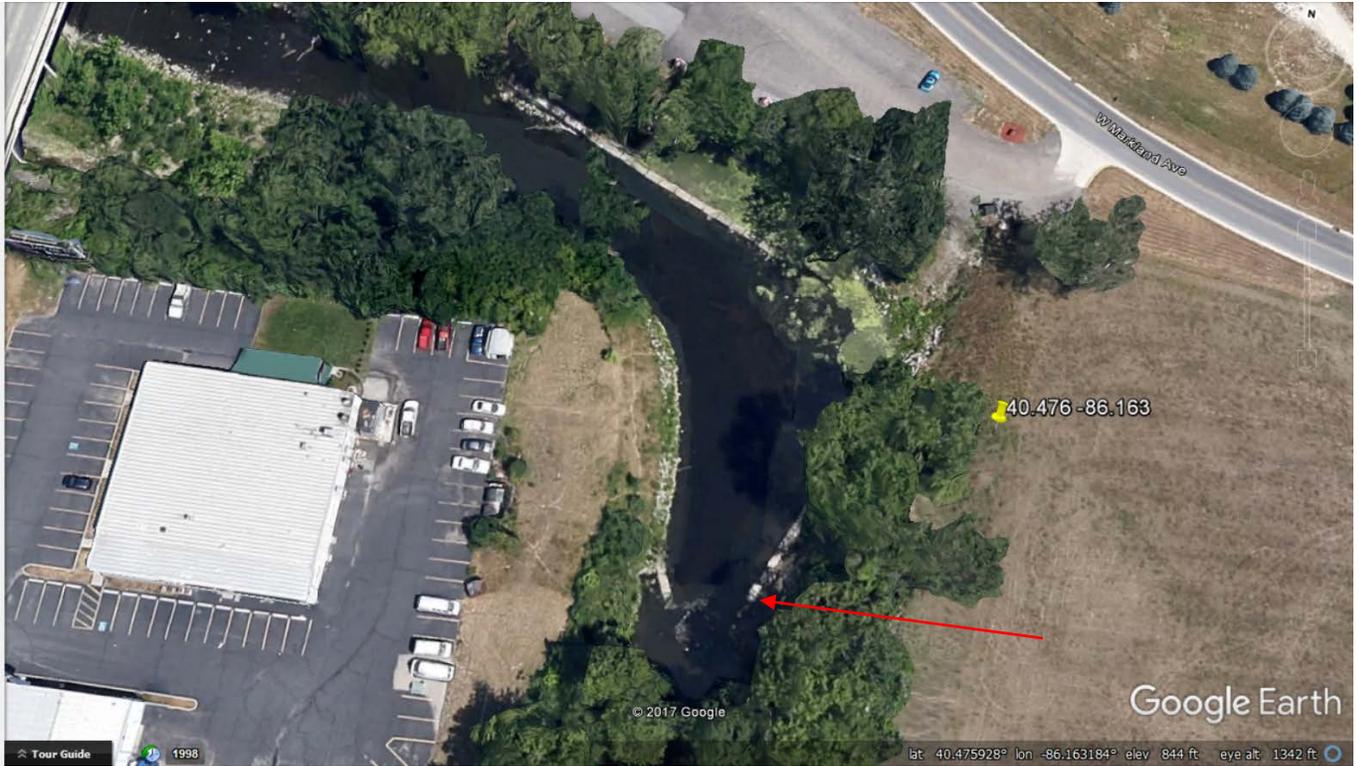
Figure 28: Wildcat Creek upstream from Dixon Road. Note what appears to be a cross-vane in the bottom center of the image (red arrow), and the line of limestone blocks armoring the right bank.

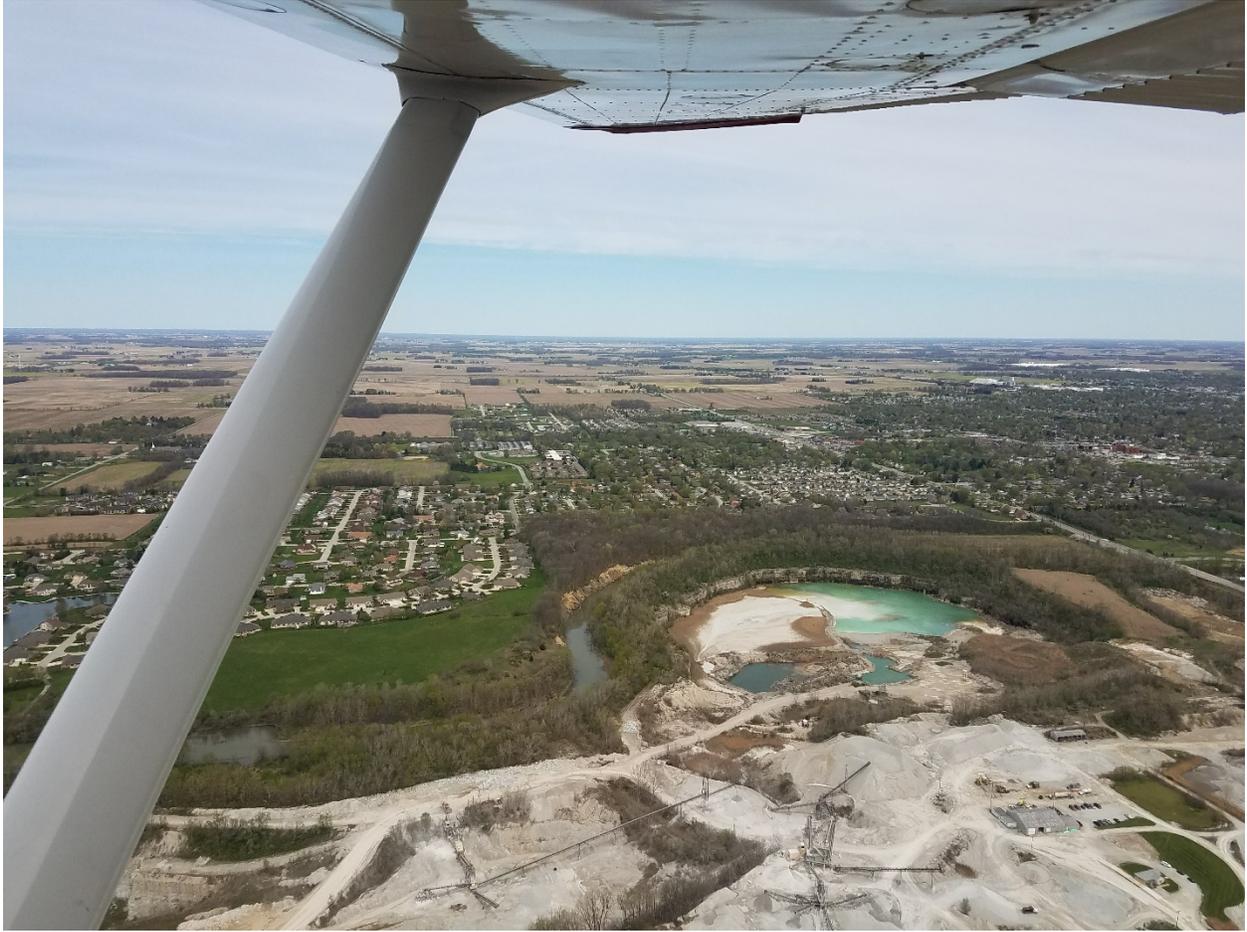
Figure 30: Large cutbank on right bank of Wildcat Creek across from Martin-Marietta quarry. The exposure is approximately 1300-feet long, and over 40 feet high.

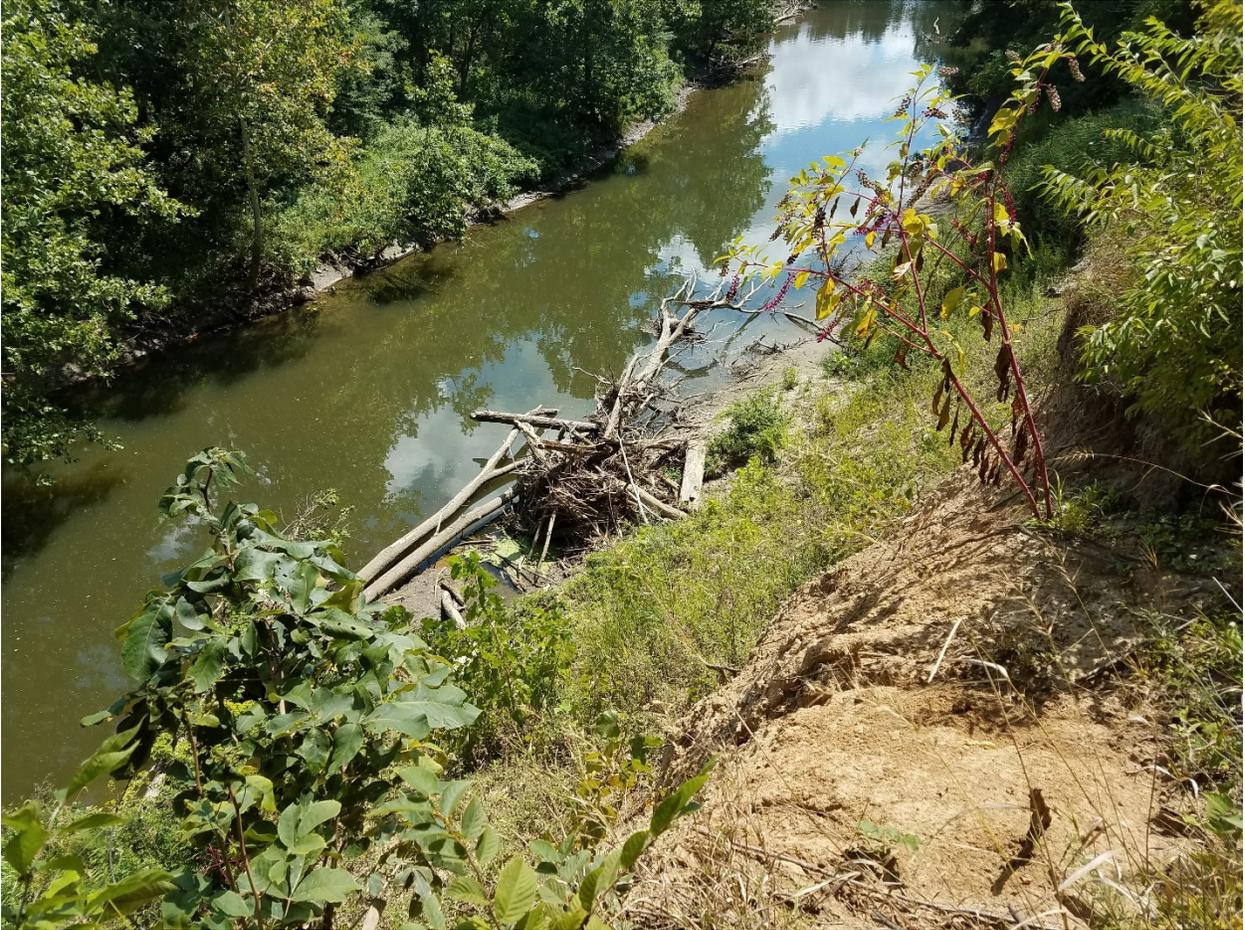
Figure 31: View of large cutbank from the top of the right bank. Note the wood oriented against the bank. This alignment helps to protect the toe of the slope and build a floodplain bench at the bottom of the slope.
