Wildcat Creek in Howard County
Stream Stability Assessment
Howard County, IN | November 2017

Howard County Stormwater District

Christopher B. Burke Engineering, LLC
115 West Washington Street, Suite 1368 South
Indianapolis, Indiana 46204

CBBEL Project No. 15-0132.00000

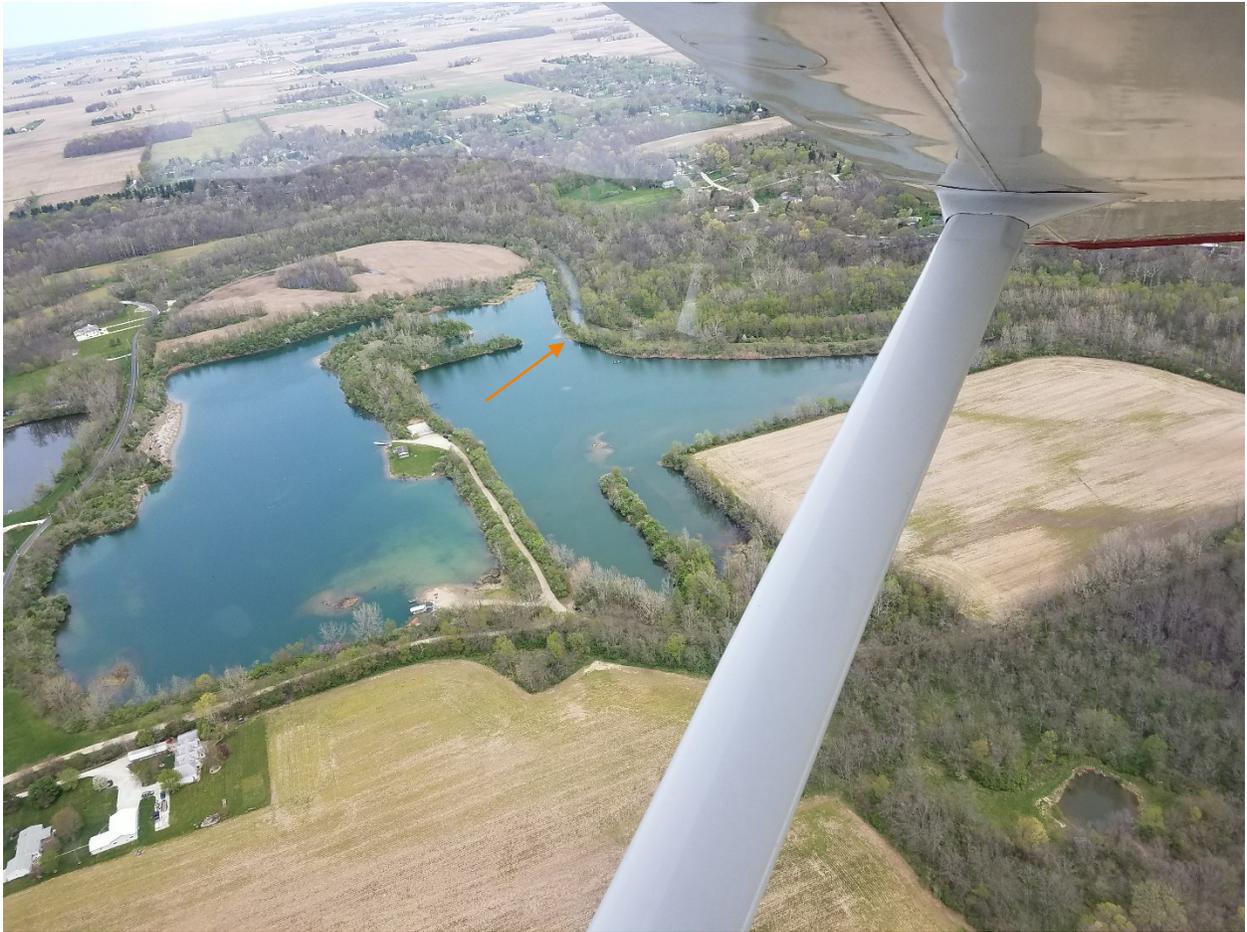
Figure 33: Looking northeast across the lake at the “new” channel (red arrow). Note proximity to levee.

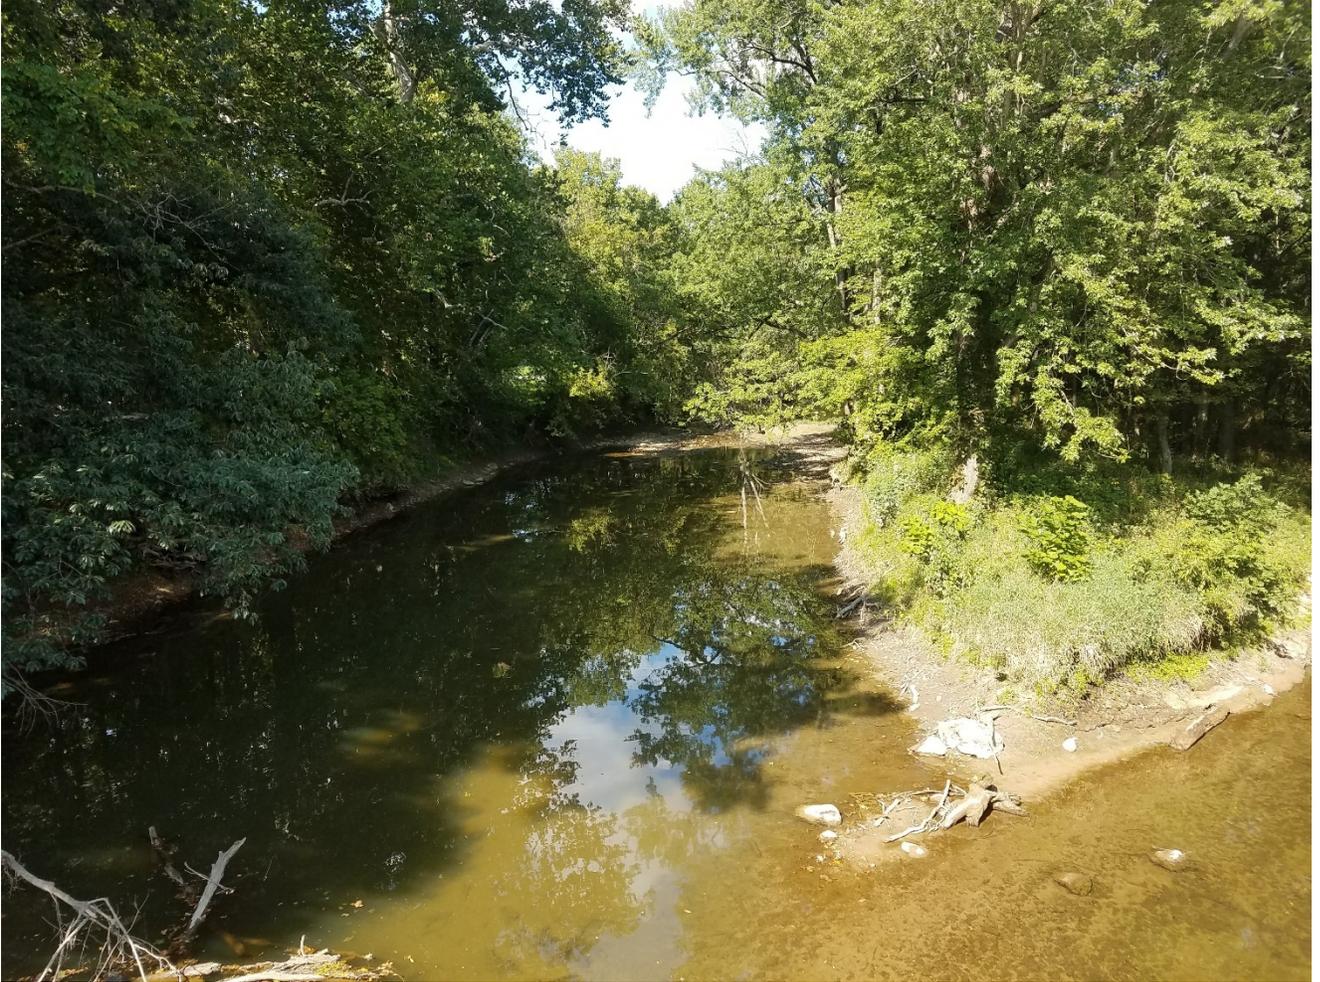
Figure 34: Wildcat Creek at CR N 400 W. The old main channel is on the left, the dry bed is visible upstream. The constructed channel is on the right, it now carries most of the flow.

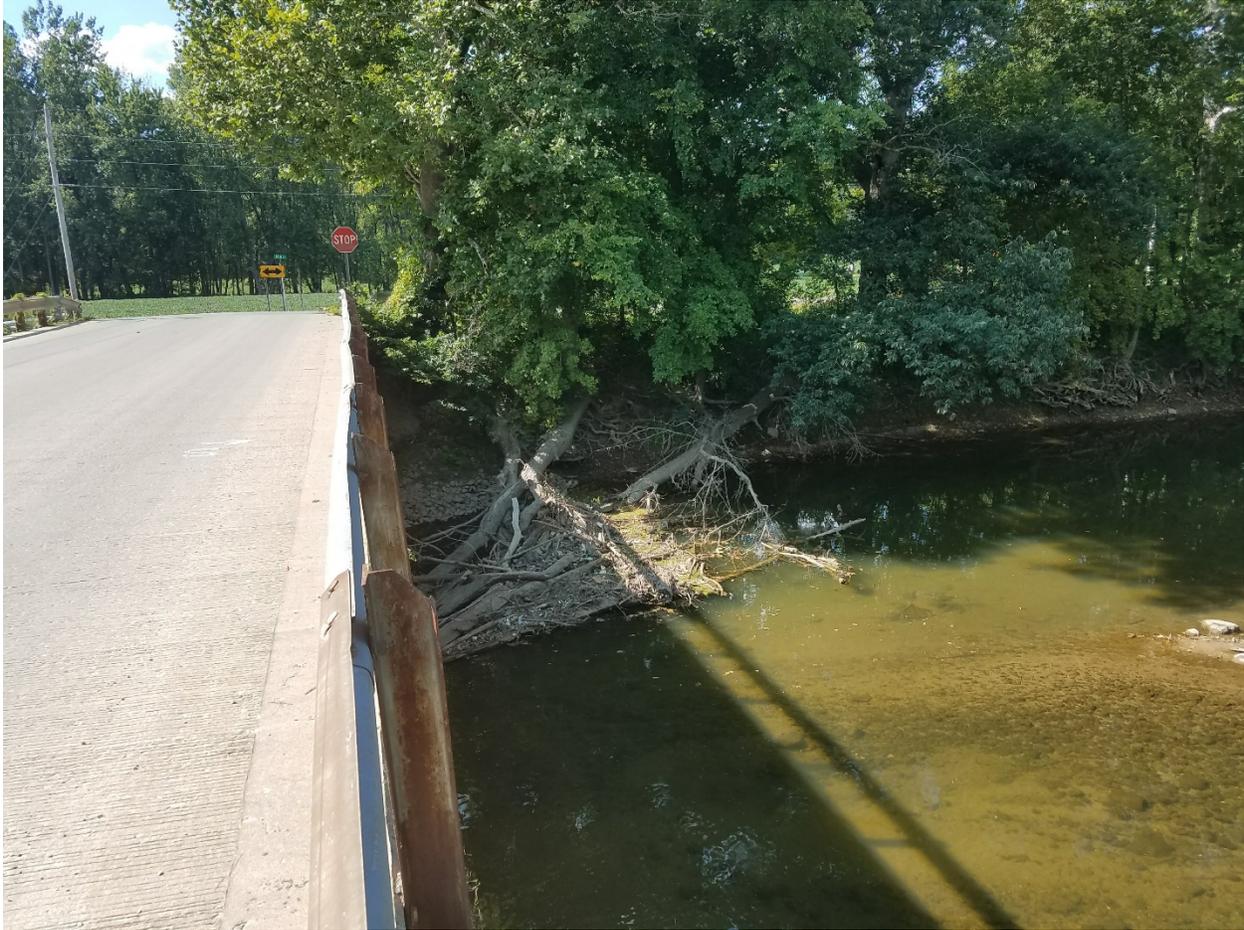
Figure 35: Wildcat Creek at CR N 400 W, large wood and debris washed out of the main channel and lodged against the bridge. This picture was taken in August following the wettest Spring and early Summer in 135 years (NWS). Howard County officials reported no wood had been cleared from the bridges this summer.

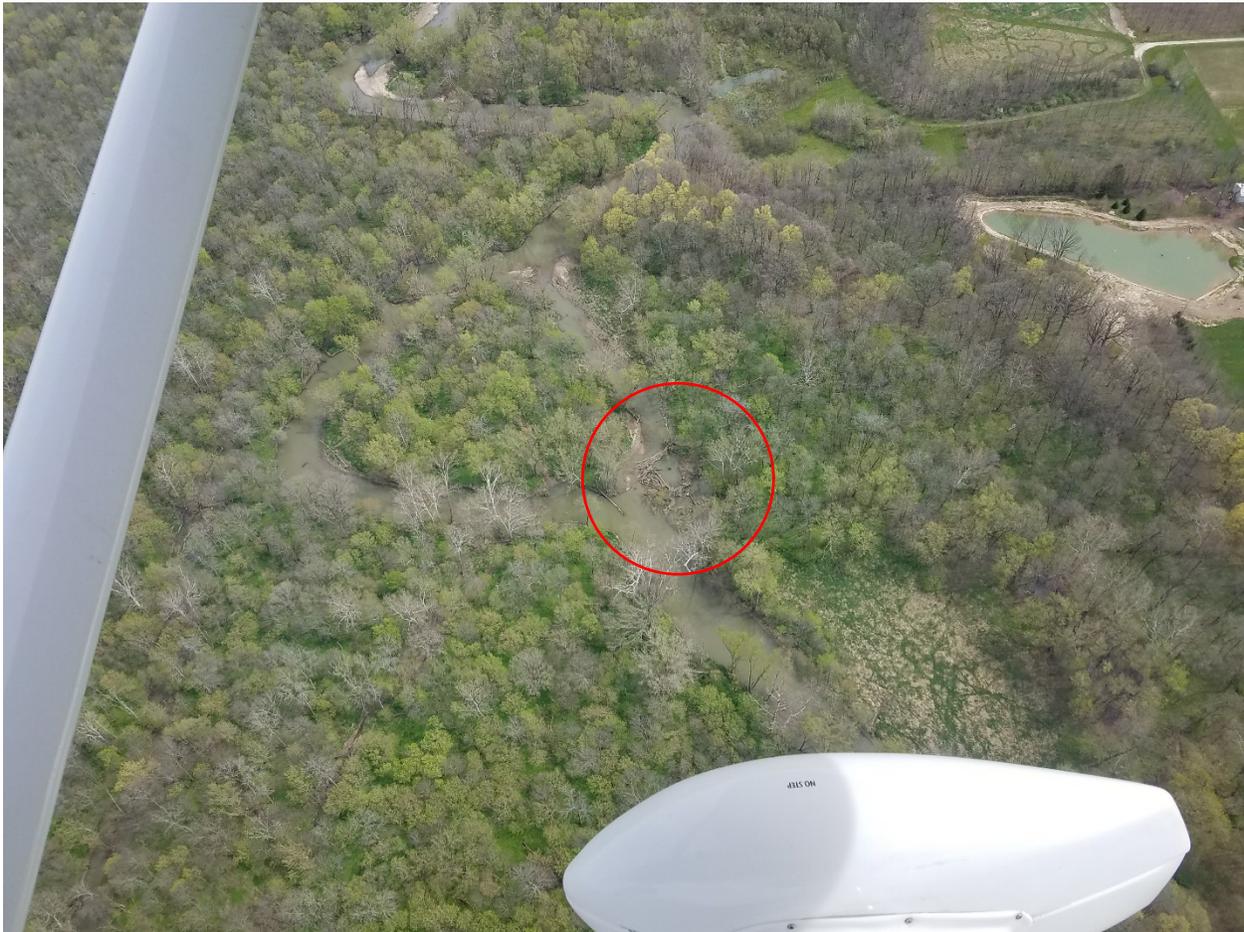
Figure 37: Looking upstream west-southwest. Note large wood in channel (red circle). This location is 0.6 miles downstream from the mined area. The channel is not completely obstructed, and the wood is not closely packed. Image was taken in Spring 2017.

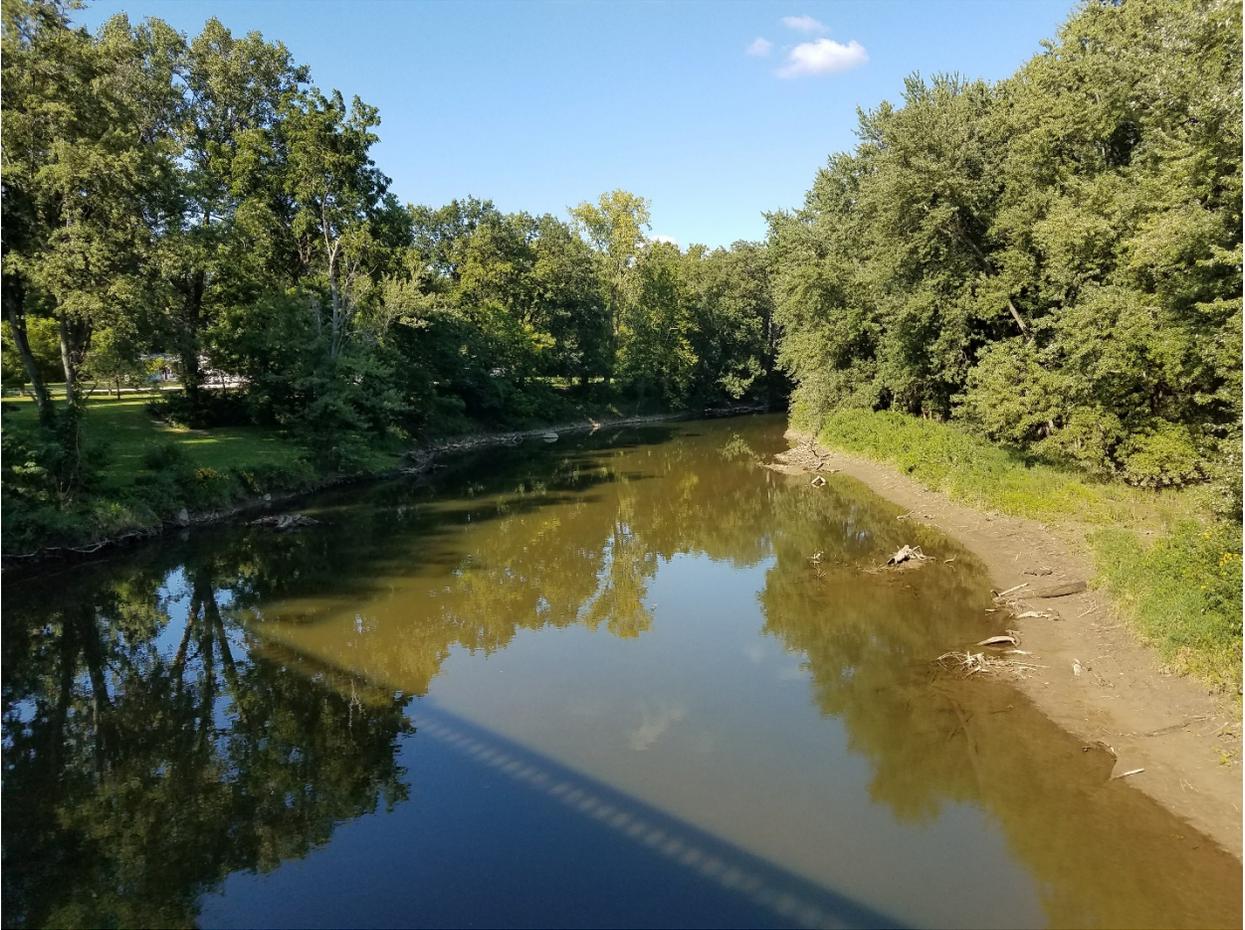
Figure 40: Wildcat Creek at CR S 750 N, looking upstream. Note terrace on right bank, stable transition to floodplain on the left bank. Mature riparian forest is present throughout most of this reach.

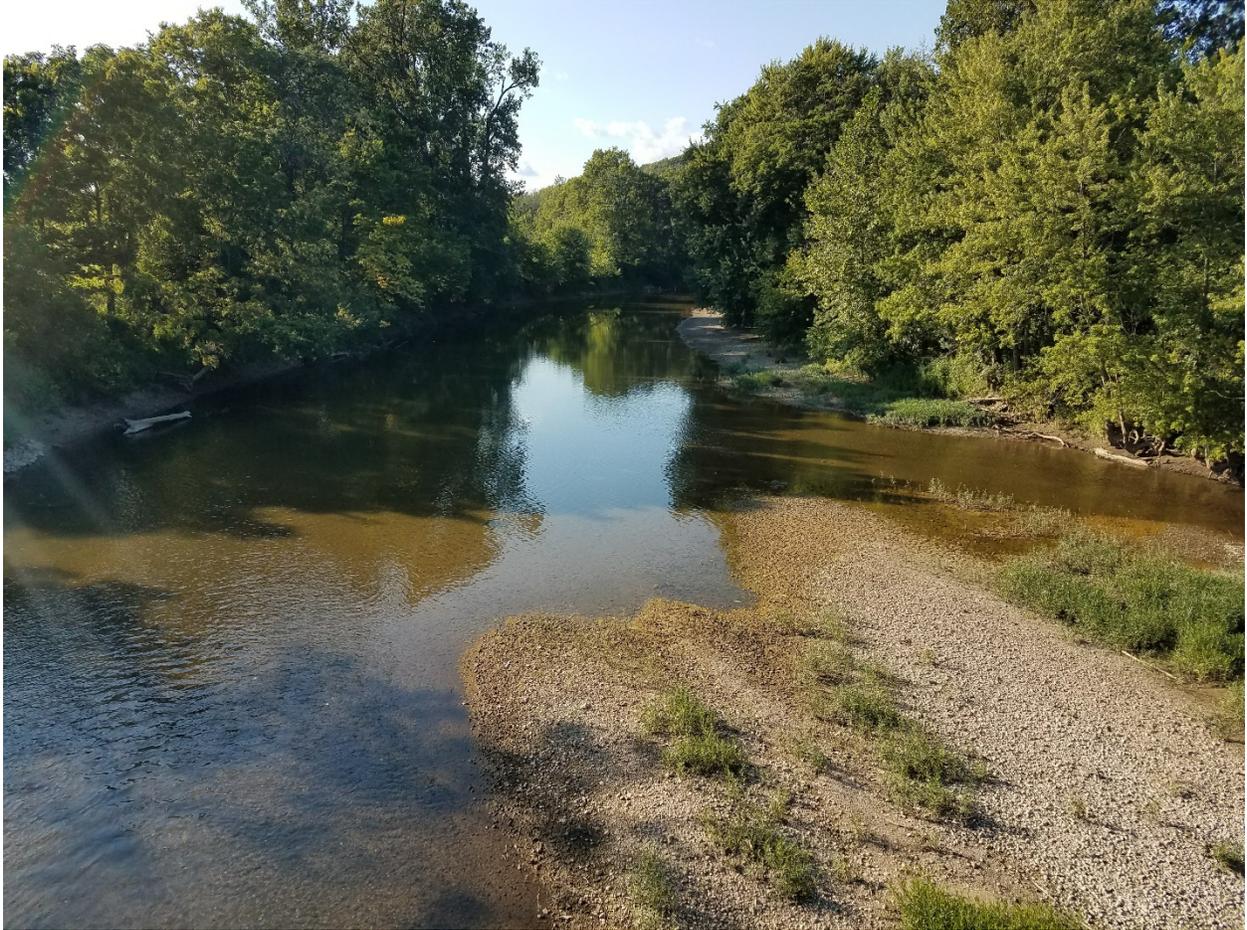
Figure 41: Wildcat Creek at SR 22, looking downstream. The large in-channel bar is caused by the bridge over SR 22. There is a borrow pit on the other side of the trees on the right side of the image.

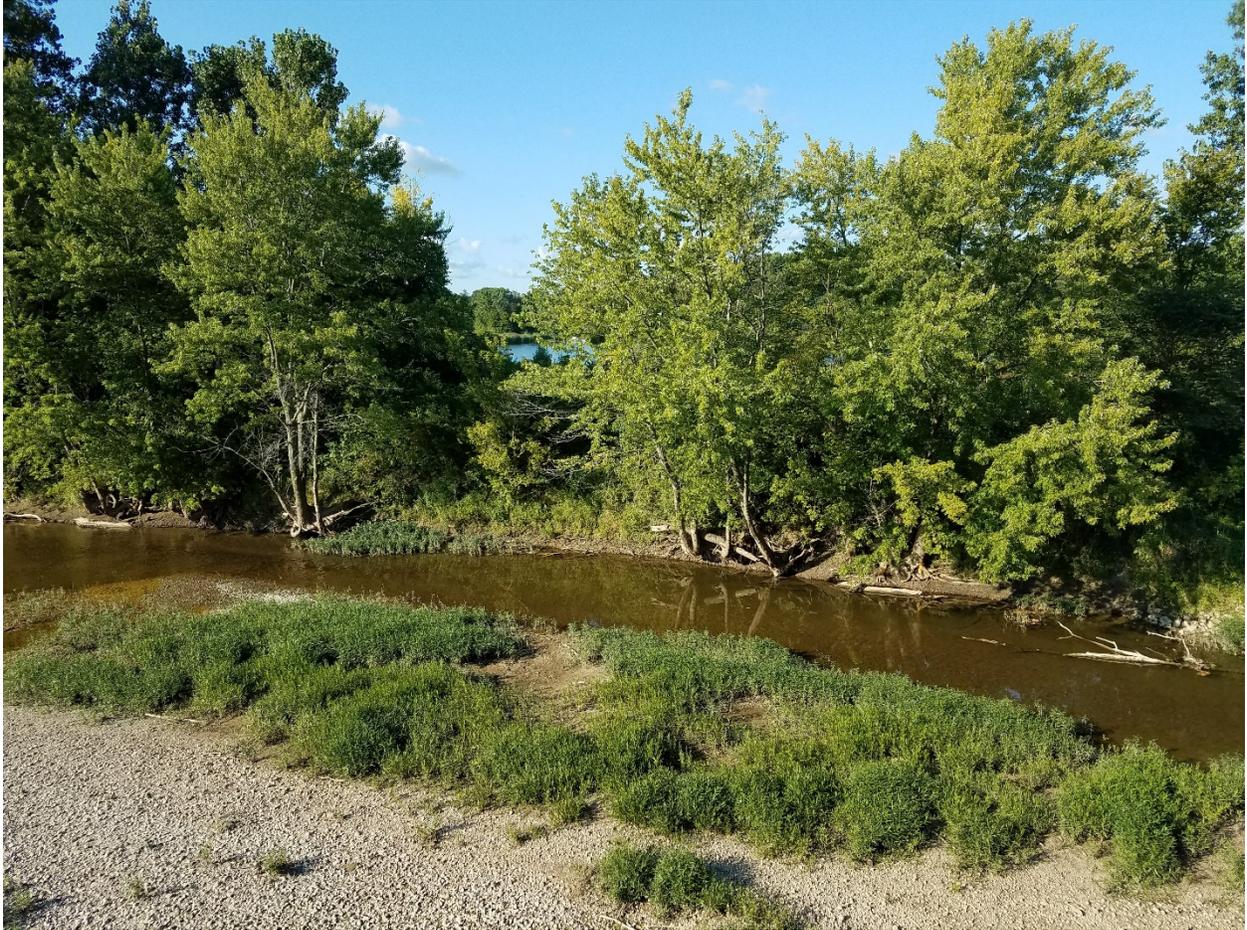
Figure 42: Wildcat Creek at SR 22, looking downstream. Borrow pit is visible through the tree gap. Note the position of the trees at the water line. In this uncohesive material the tree roots are holding the bank together.

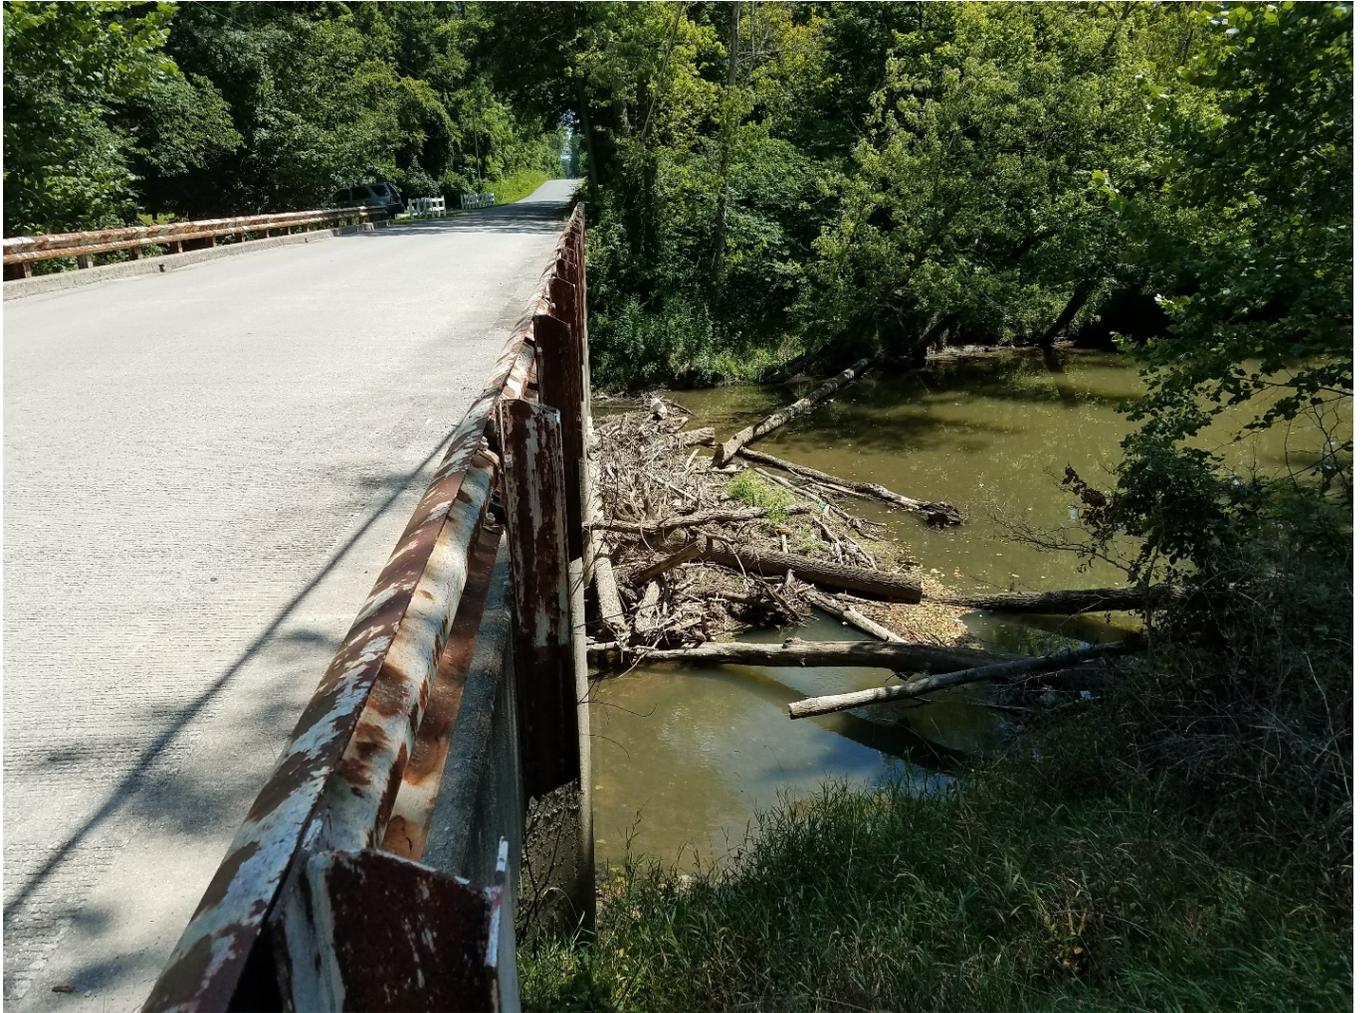
Figure 2: Mud Creek, just upstream of the confluence with Middle Fork Wildcat Creek. This is the first location where LW was found at a bridge. August, 2017

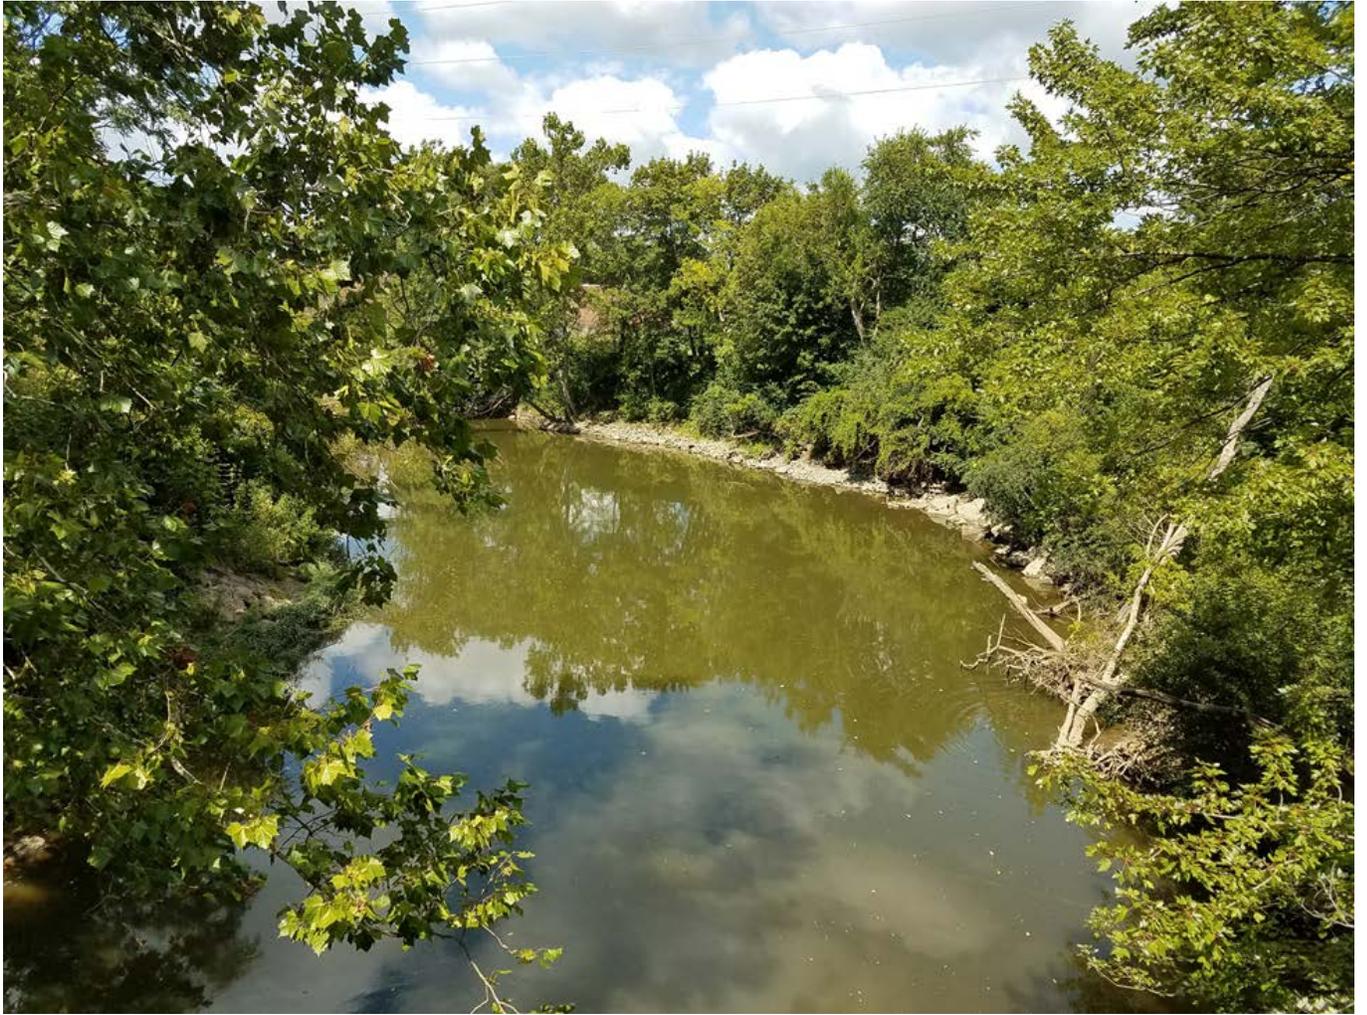
Figure 4: Wildcat Creek at Pedestrian Bridge upstream from Apperson Street, Kokomo Right bank, looking downstream. Wood is oriented along right bank. August, 2017

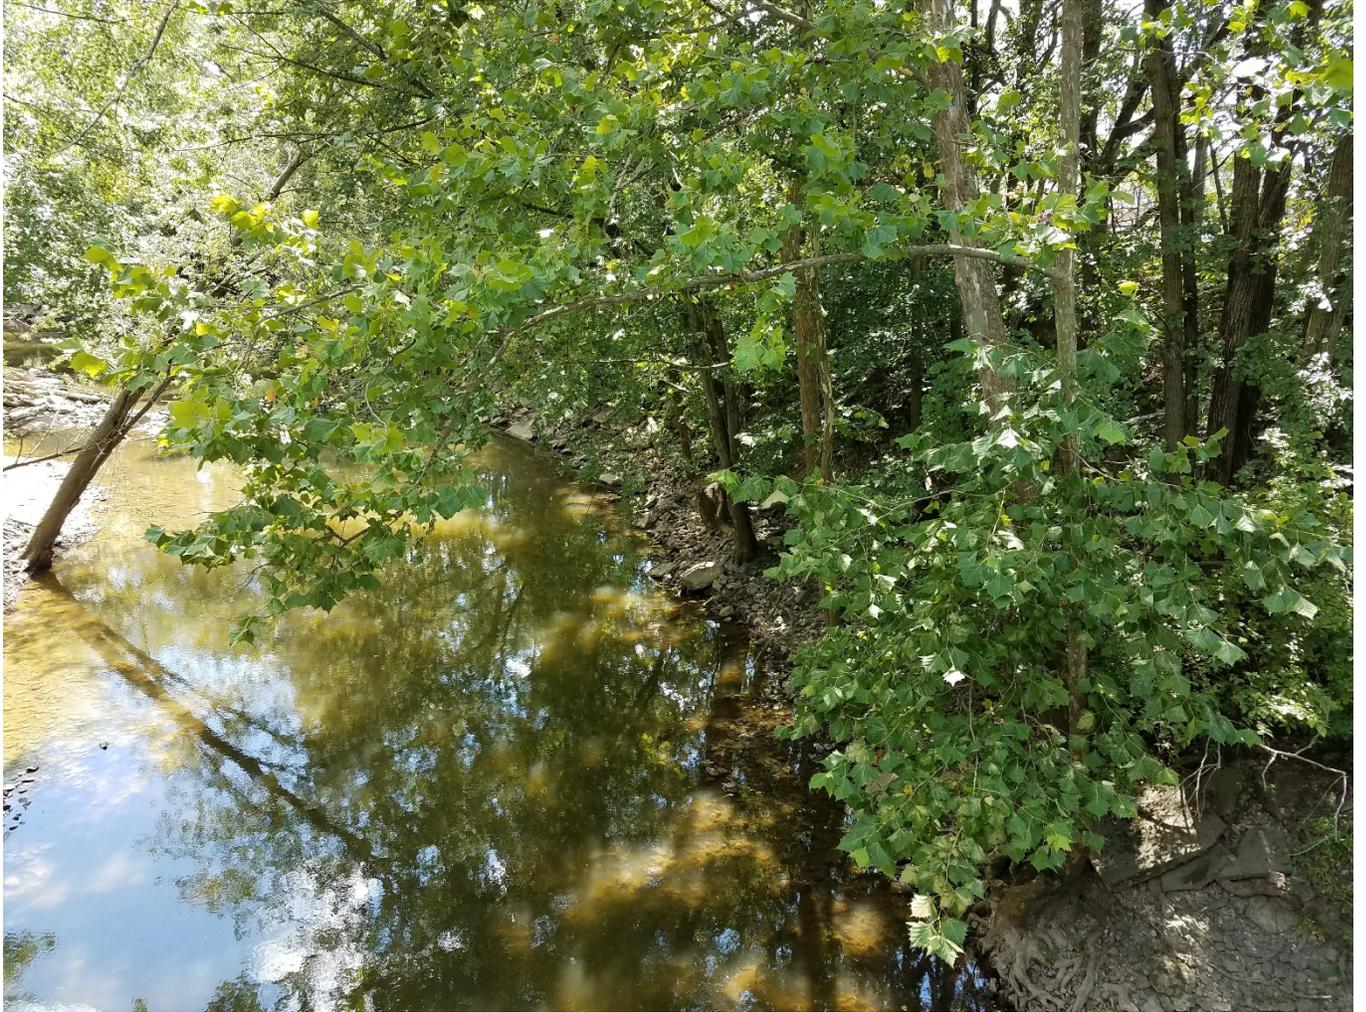
Figure 5: Wildcat Creek at Apperson Street, Kokomo Right bank looking upstream. Note stable banks, dominant woody vegetation are native riparian tree species. On the left side of the image a tree growing on the right side of an in-channel bar is visible. August, 2017

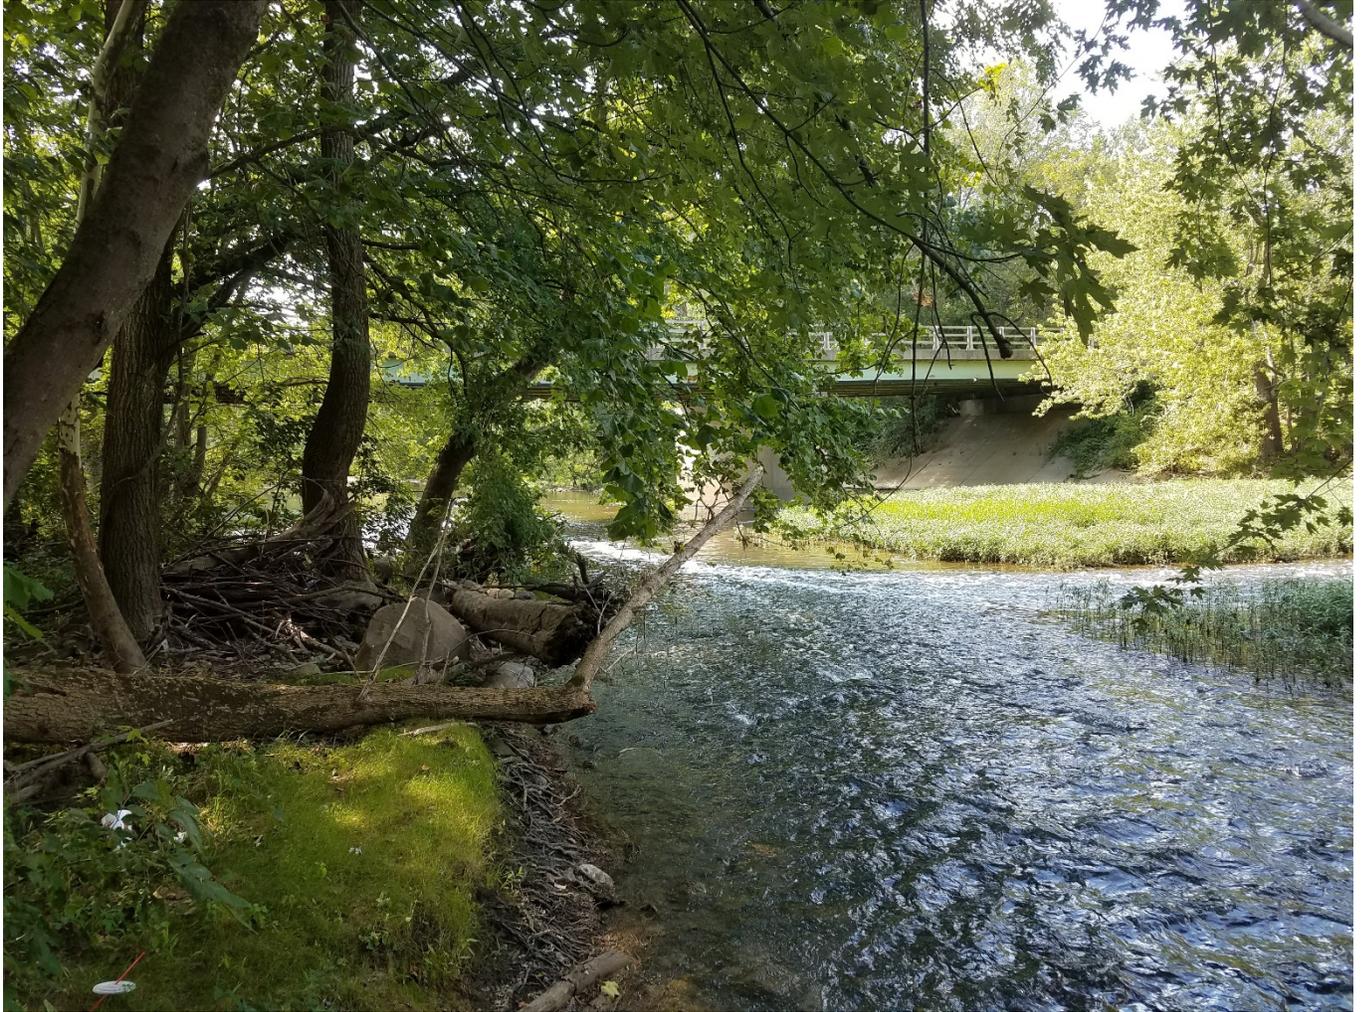
Figure 6: Wildcat Creek at Malfalfa Road. Looking downstream. Wood on left bank is reducing velocity and promoting deposition on the floodplain. Wood on the floodplain is an important aspect of floodplain diversity. August, 2017

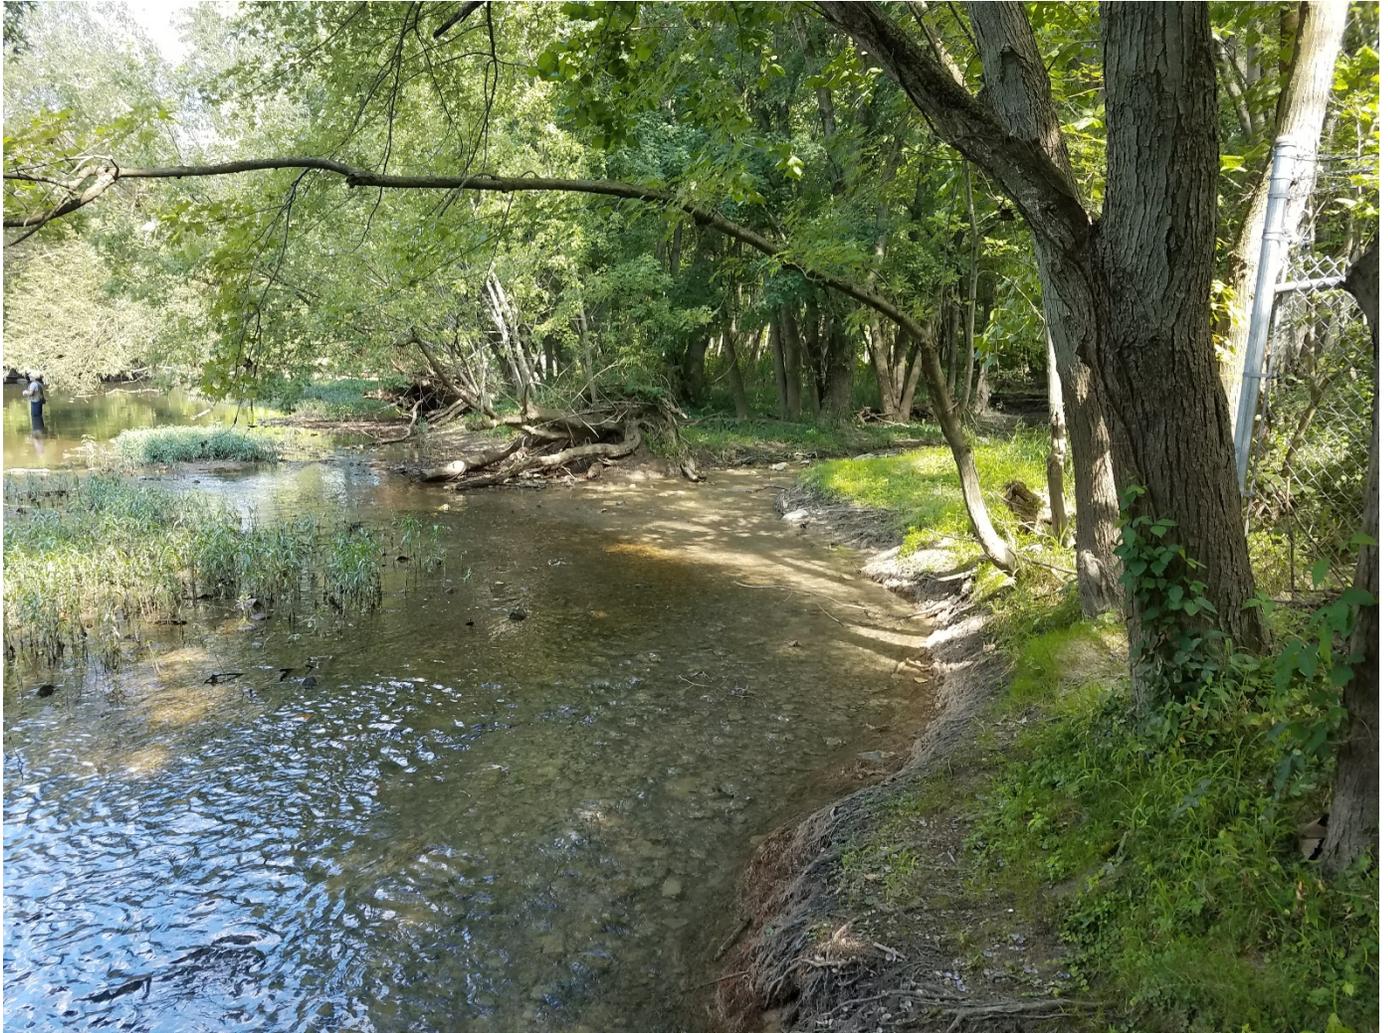
Figure 7: Wildcat Creek at Malfalfa Road. Looking upstream. Quarry drainage channel is visible in the upper right. Wood on left bank is reducing velocity and promoting deposition on the floodplain. August, 2017

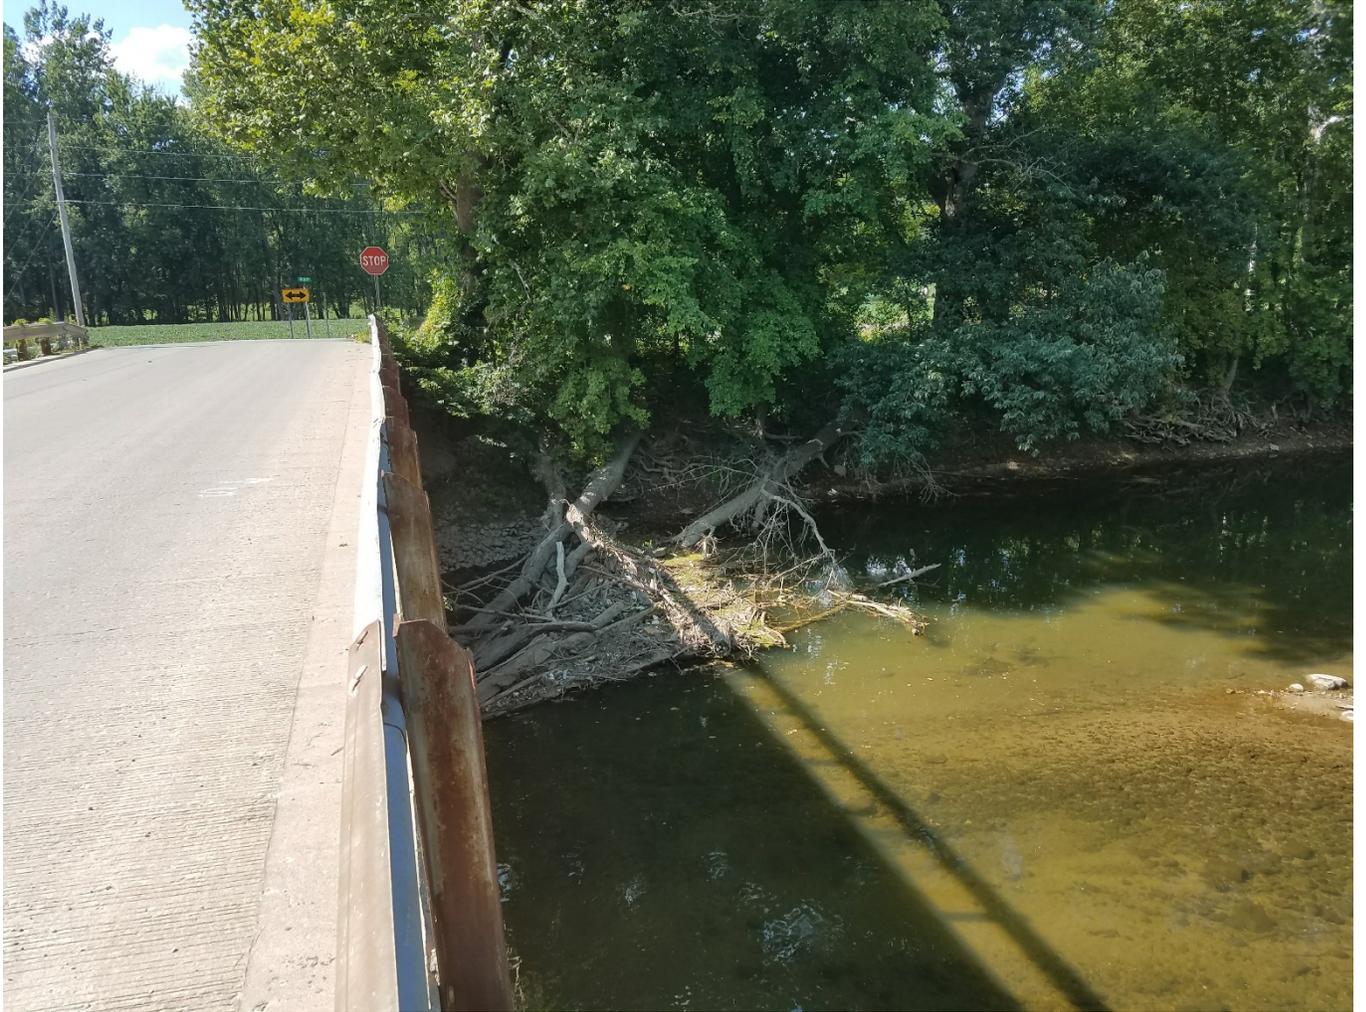
Figure 8: Wildcat Creek at County Road 400W. At the confluence of the main channel and the drainage bypass channel at the old quarry. The main flow is now moving through the constructed bypass channel. Low flows on the main channel cause wood to accumulate and get pushed out by flood waters. August, 2017.

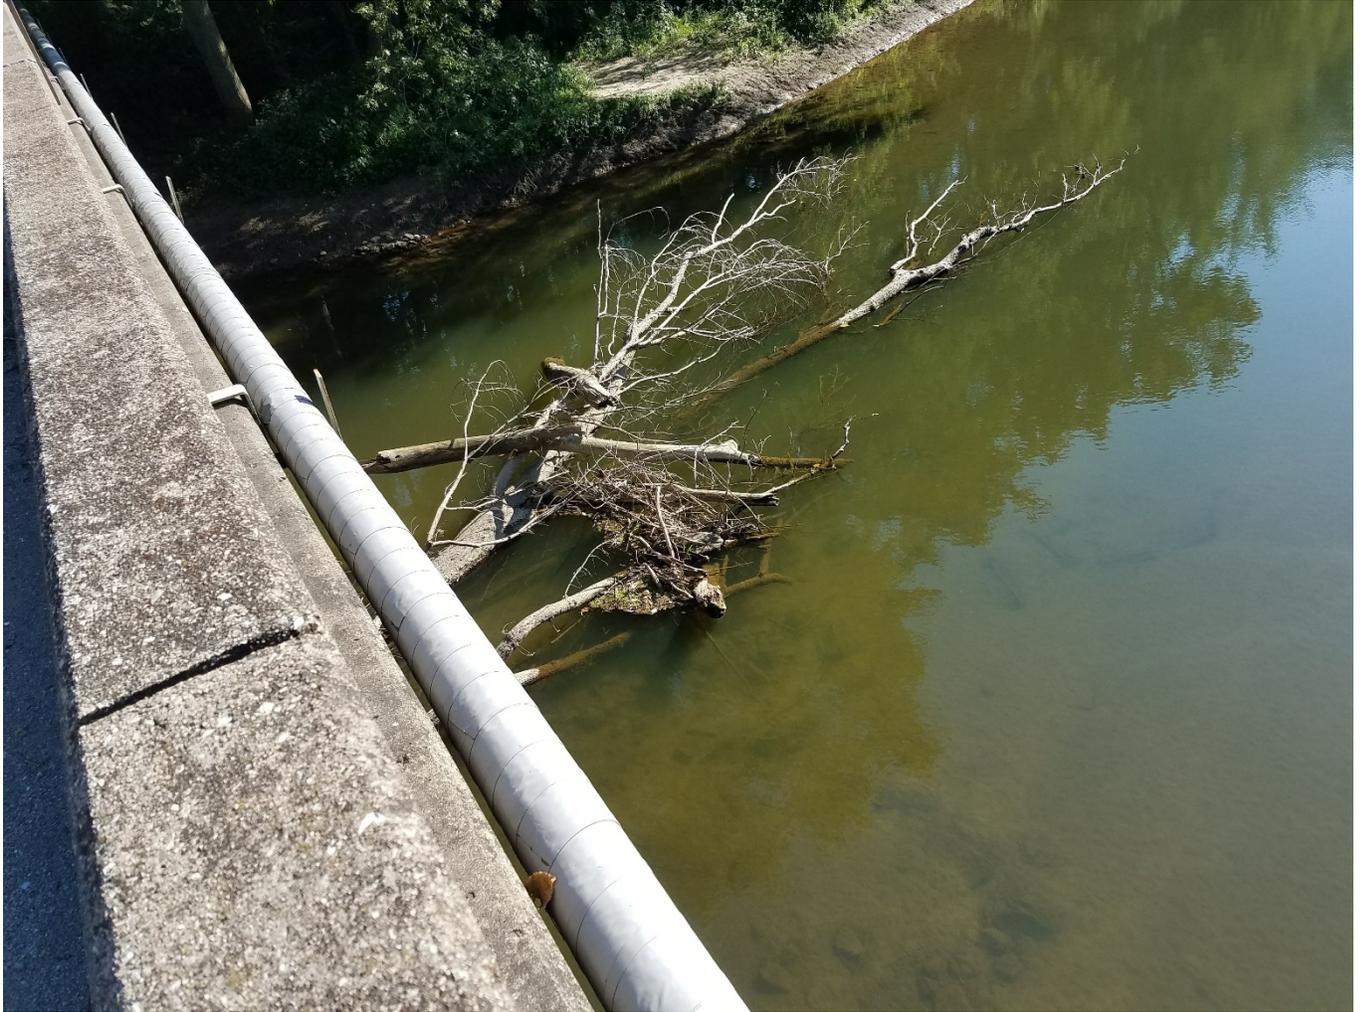
Figure 9: Wildcat Creek at County Road 750. Left Bank, downstream. One tree is lodged in one cell of the bridge. No flow obstruction. August, 2017.
